TECHNICAL BROCHURE

HVDC transformer failure survey results from 2013 to 2020

Reference: 859

AG B4.04

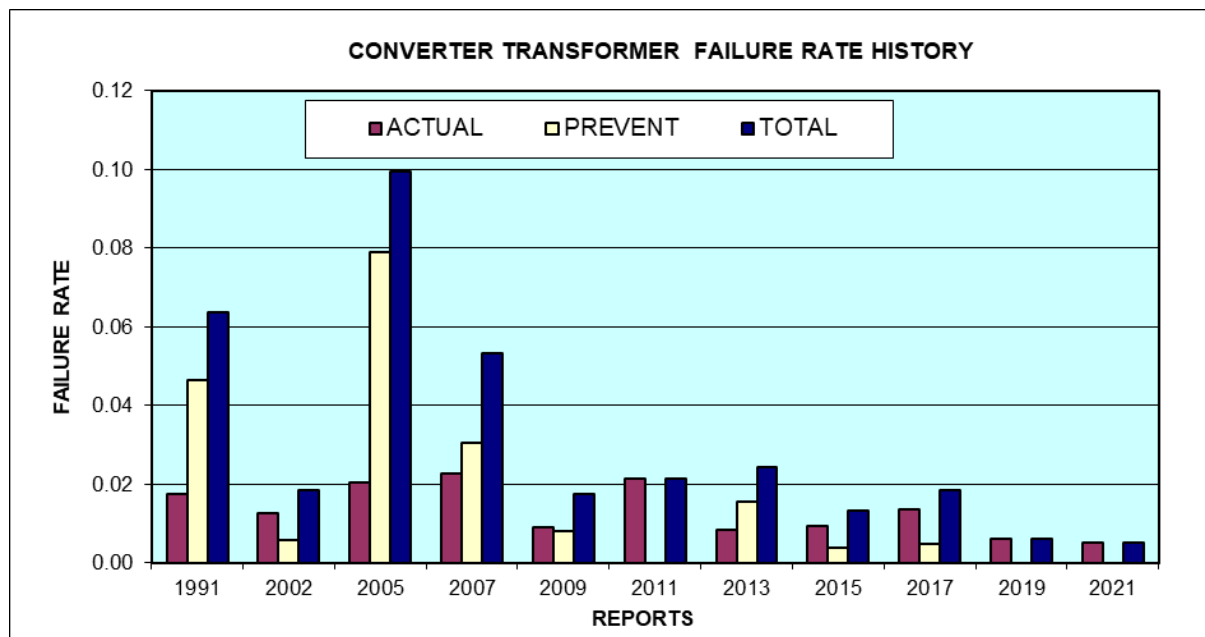
Figure 7-1- Failure Rate for the period 1972 to 2020

It can be observed in Figure 7-1 that following a reduced failure rate in the period from 1991 to 2002, there was a significant increase in the period from 2003 to 2006 (2005 and 2007 report). The failure rate in last three reports (2009 to 2019) decreased to same level as the rate recorded for the period 1991 to 2002. Failure rate in 2019 and 2021 reports is less than 0.006. In addition majority of these failures are on systems more than 25 years old.

This finding is encouraging, indicating a potential effect of the latest version of the IEC 61378-3 [6] standard as well as a strong action that followed an upsurge of the HVDC Converter Transformers caused to a full or a partial extent by corrosive oil.

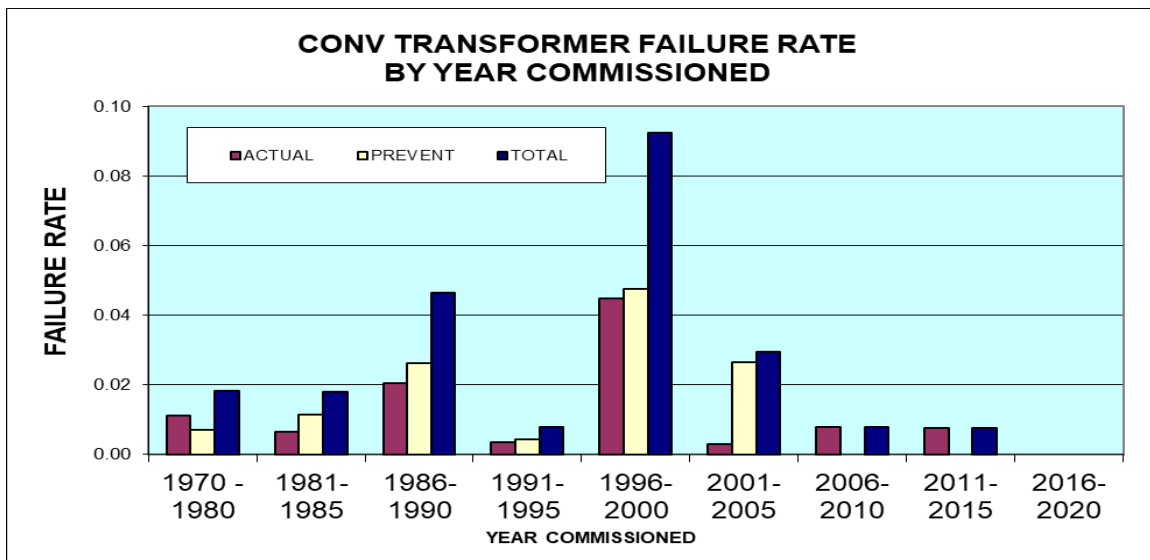
Figure 7-2 - Converter Transformer failure rate by year of commissioning

For systems installed between 2001 and 2010, the preventive failure rate is slightly higher than the actual failure rate. This phenomenon could be attributed to the following;

- Modern transformers are now more closely monitored (e.g. on-line gas monitoring).
- Most of the systems are designed with spare transformers being readily available so that when a potential problem occurs the unit can be changed before the actual failure.

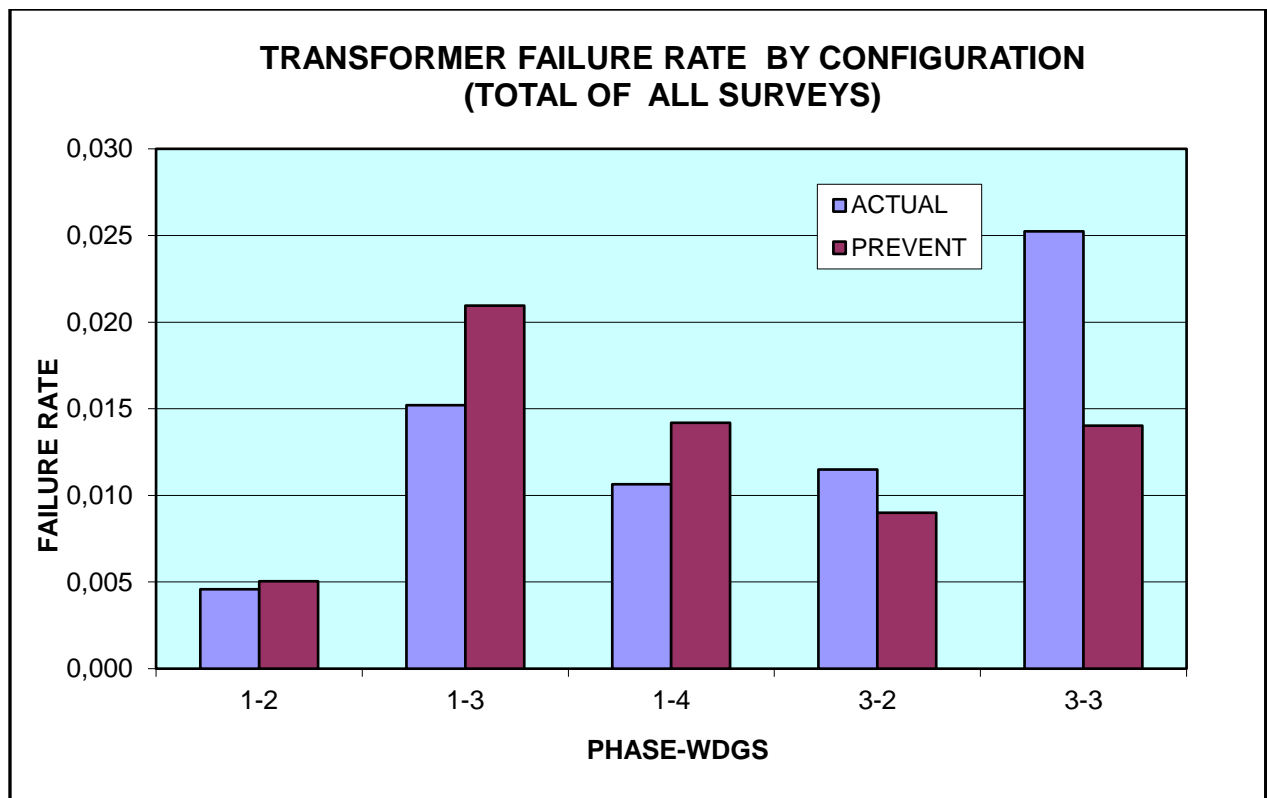
Figure 7-3 - Failure rate of transformers by configuration

Figures 7-3 and 7-4 show that **most failures occurred in single phase units containing line winding and star and delta valve windings**. These transformers were of the ratings 275 MVA and above and installed in the HVDC systems of 500 kV or above. This increased failure rate could be associated with the complex winding insulation and lead exit design.

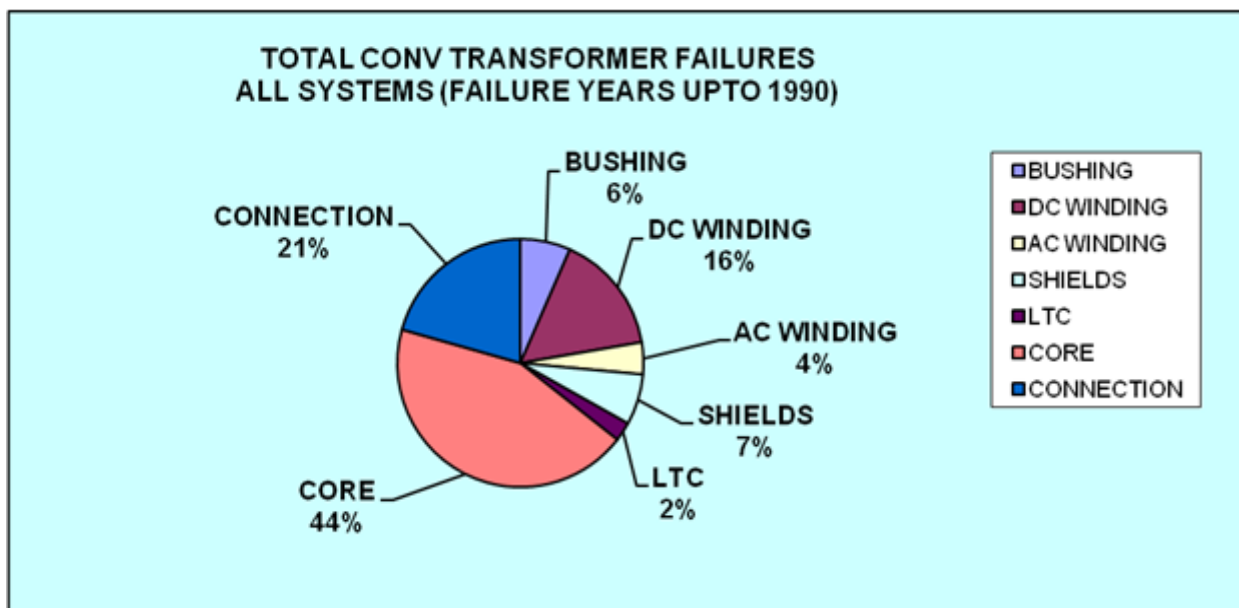
Figure 7-5- Failure by components up to 1990

Core	44%
Connections	21%
DC winding	16%

JTF 12-14/10-01 made several recommendations for changes to test procedure and design review process. See ref [1] for more information.

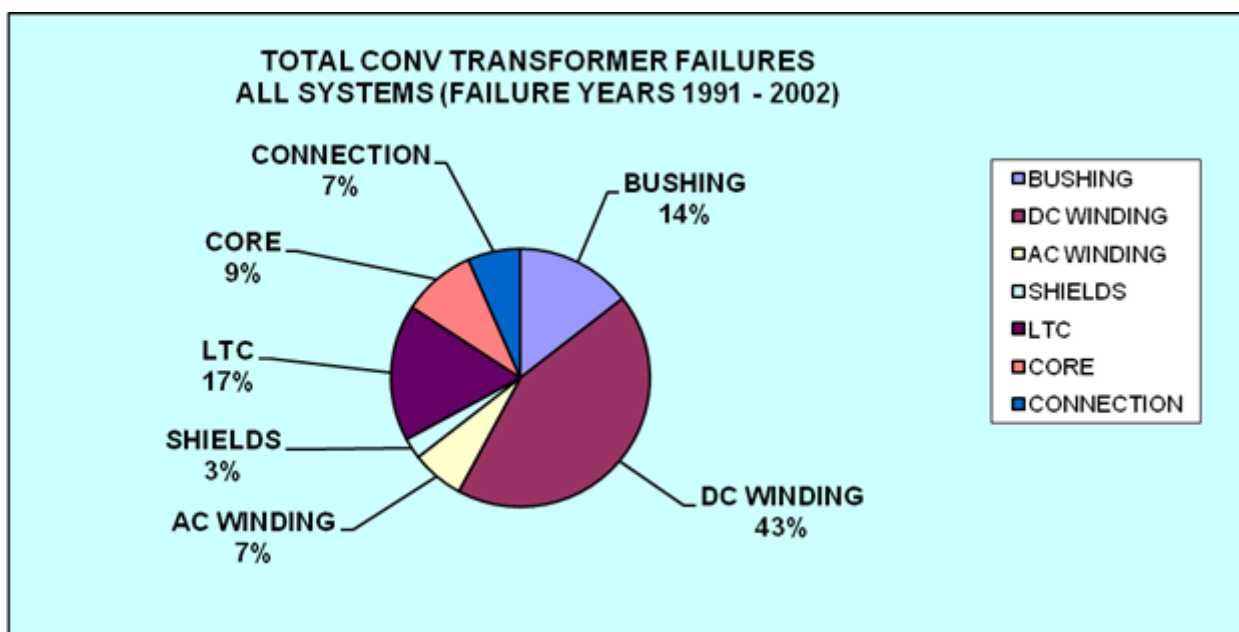
Figure 7-6 – Failure by component 1991 to 2002

Figure 7-6 show all failures reported in JTF B4.04/A2-1 report [2] from 1991 to 2002. The three major causes of failure during this period were as following;

DC winding	43%
Tap Changer	17%
Bushing	14%

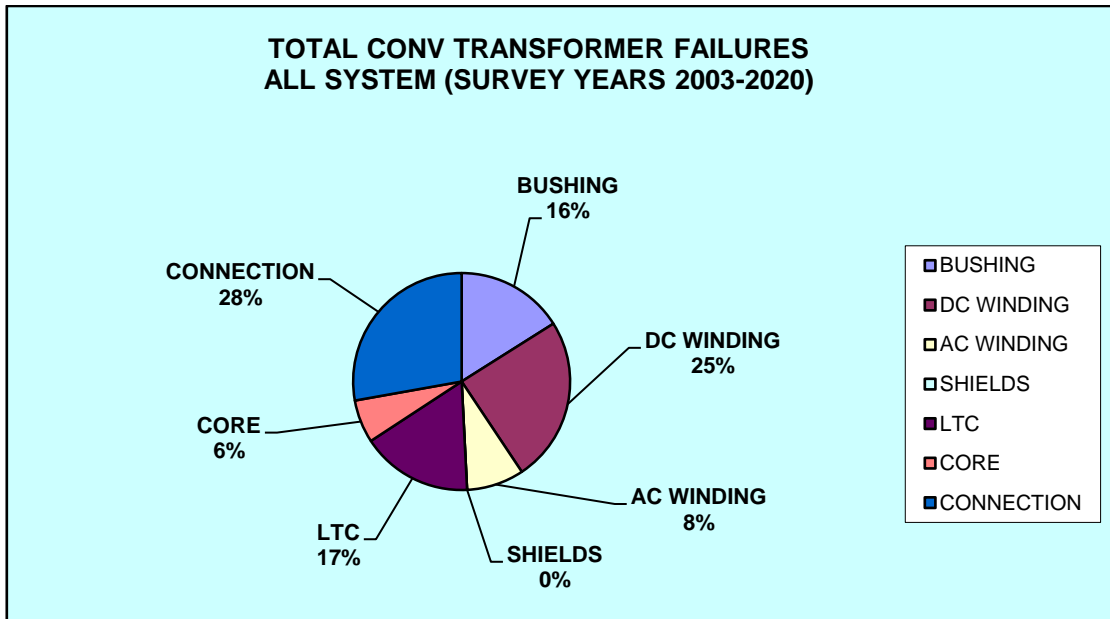
Figure 7-7 – Failure by component 2003 -2020 (All systems)

Figure 7-7 shows the total failures (actual and preventive) by components, for the period from 2003 to 2020 (combined). Figure 7-7 includes all the systems that reported irrespective of the year of installation.

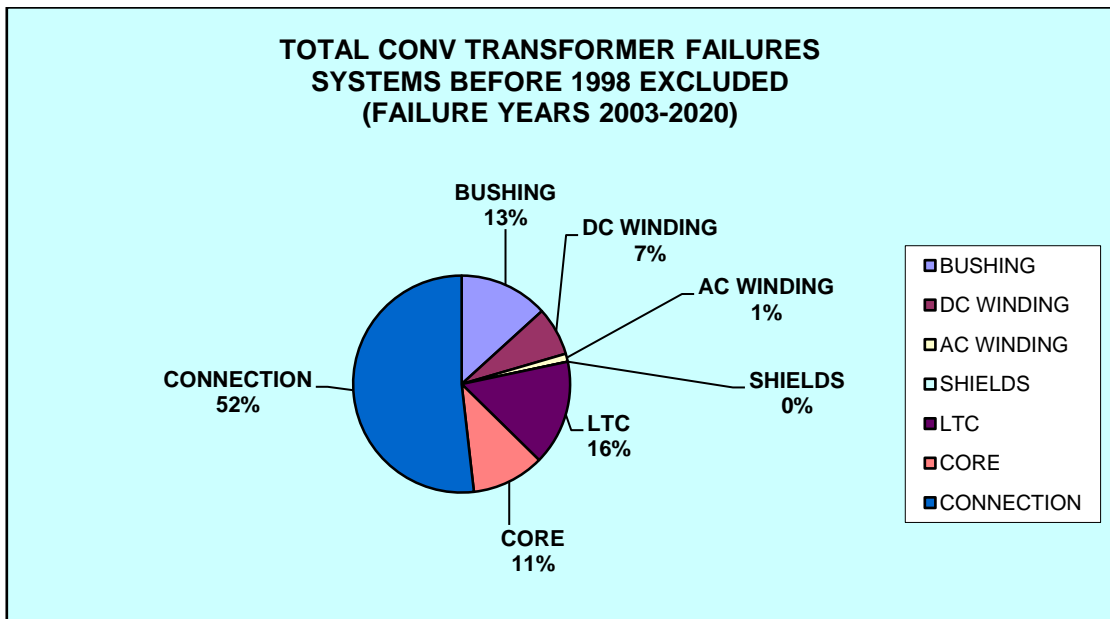
Figure 7-8 - Failures by component 2003-2020 excluding systems commissioned before 1998

Figure 7-8 shows the total failures (actual and preventive) by component for the systems installed in 1998 or later. The percentage failures by components are as following

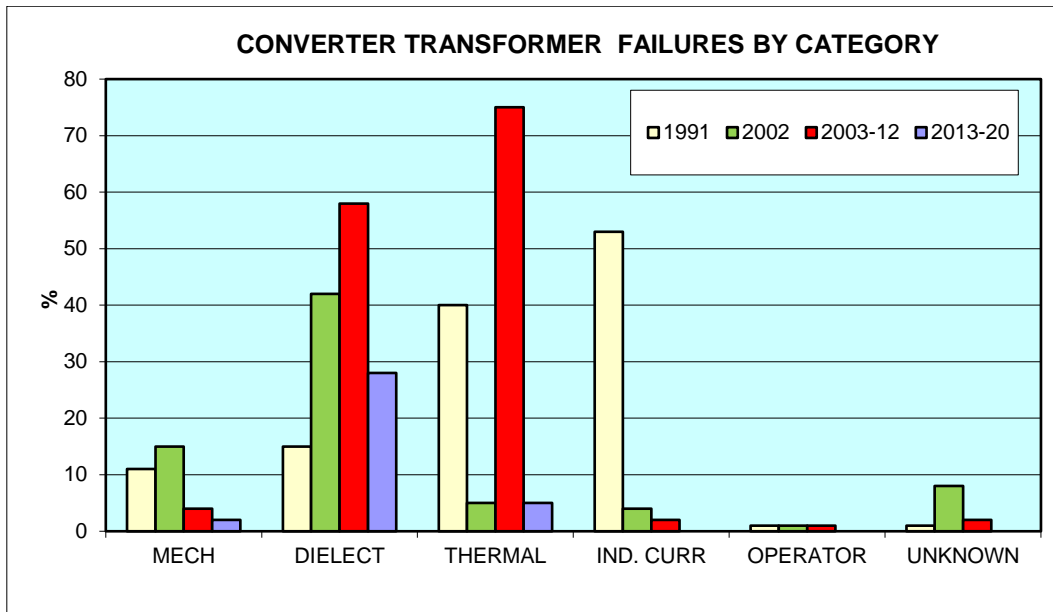
Figure 7-9 – Probable cause of failures

Figure 7-9 shows that following the recommendations of JTF 12/14 10-1, the failures due to induced current have been successfully mitigated. The mechanical failures are mostly related to bushings and LTCs. The dielectric and thermal failures continue to be the two dominant causes. For systems commissioned after 1998 the failures in the connections (figure 7-8) are mostly due to thermal overheating (figure 7-9).

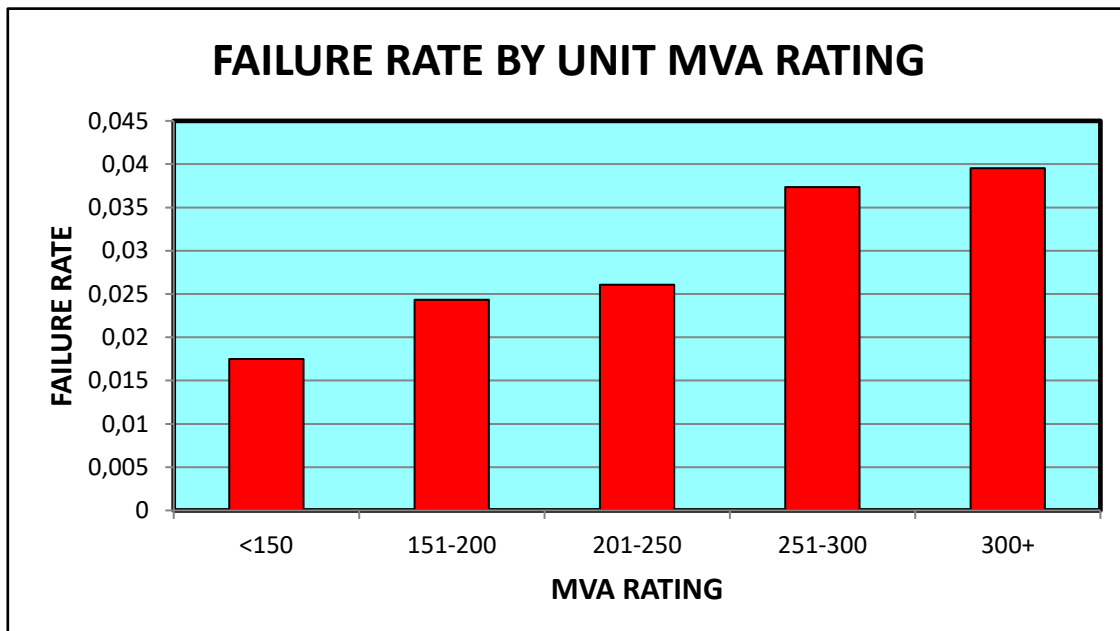
Figure 7-10 - Failure rate by unit MVA rating

Figure 7-10 shows the failure rate of converter transformers as a function of unit MVA rating. The failure rate increases as the unit rating increases. Higher rating presents a challenge of keeping the dimensions as small as possible for transportation reasons and at the same time meet all the electrical clearances and provide sufficient cooling of all the parts.
