Archaeological sites in Nepal and India: Concerns of lightning risks

Abstract— This study investigates the present-day lightning risks of a large number of archaeological sites in Asia, with special attention to religious monuments in South Asia with invaluable historical value. The study reveals that in most cases, no lightning protection measures (LPM) have been adopted and in several structures, LPM have been adopted but without conducting a methodical risk assessment or standard system design under experts' advice. In a majority of archaeological buildings in Nepal, appropriate lightning protection systems have not been installed, though an apparent air termination system could be observed in the form of a metallic spire or a metallic roof component. However, a system of down conductors and earth terminations has not been properly installed or not installed at all. Both the Department of archaeology and the Department of Urban Development and Building Construction (DUDBC) have not taken adequate steps to install LPS in archaeological sites fearing losing the aesthetic appearance and historical values of the structures. Appropriate LPM has not been adopted even on the structure

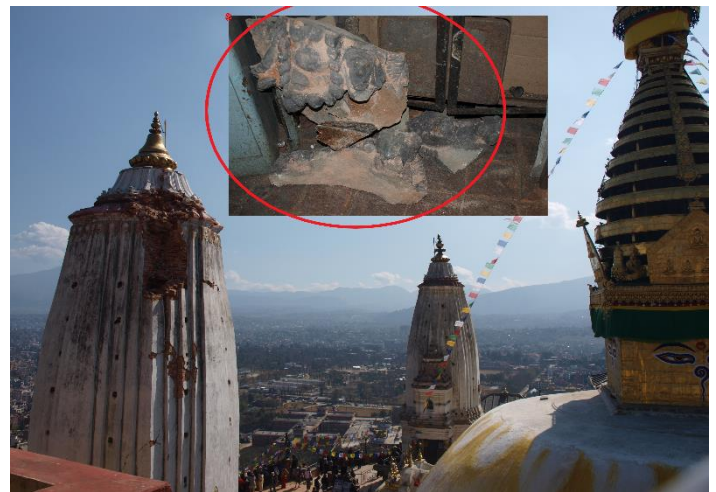
Among them, the Pratappur temple was struck and destroyed by lightning on 13th February 2011. Shown in figure 3 is a photograph of a damaged temple taken on the next day it was struck. Pratappur temple was destroyed by lightning sparing the taller structure since it did not have proper lightning protective measures. No appropriate lightning protection measures can be seen on the structure even though it was recently built (Figure 4).

Figure 3: The damaged Pratappur temple at Swyambhunath along with the main stupa and Anantapur temple. Also, shown in the inset is the damaged stone statue that was placed on one side of the main entrance door of the damaged temple.

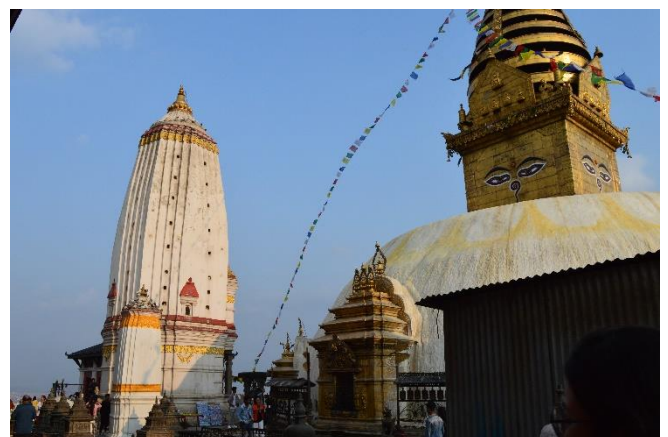
Instead, it is claimed by the local priest that LPM was done within the building after it was erected. Whereas,

- There was no visible air terminal on any of the structures.
- No available down conductors on either of the temple.
- No earth termination system could be observed.

Figure 4: The newly constructed Pratappur temple after it was destroyed by lightning in 2011.

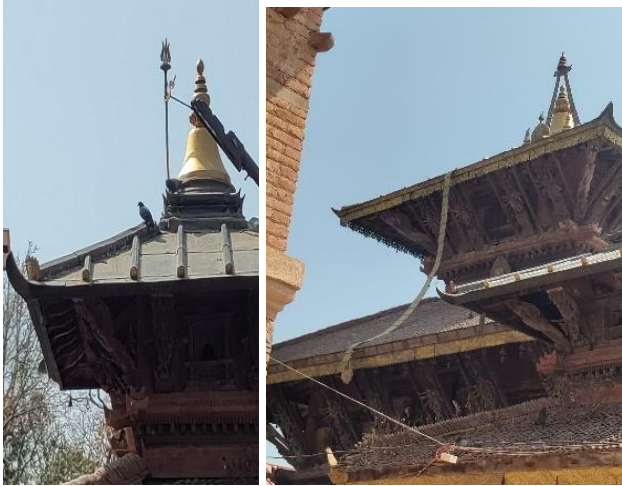
No protective measures against lightning have been taken as it is believed that the gajur (steeple) of the temple itself protects it from lightning. This temple is also a UNESCO world heritage site that is located atop a small hill to the north of Bhaktapur (Figure 5).

Figure 5: Changu Narayan temple located atop a small hill at Bhaktapur. The photograph on the left depicts an air termination system whereas the photograph on the right depicts the down conductor dangling towards the bottom edge of the roof.

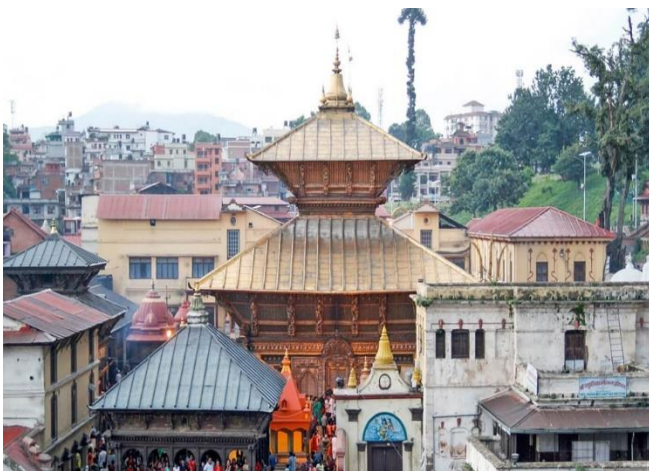
This temple is a sacred Hindu temple classified as a UNESCO world heritage site in 1979 that is believed to have been built in 400 BCE. Despite its historical and religious importance, no appropriate protective measures have been taken. It is believed that the metal steeple and the gold-plated metallic roof protect the temple from lightning (Figure 6). In this temple too, there is a trailing metallic strip that runs from the steeple and dangling below the roof.

Figure 6: Pashupatinath temple located at the bank of Bagmati river in Kathmandu. The steeple and the metallic roof are seen in the photograph.

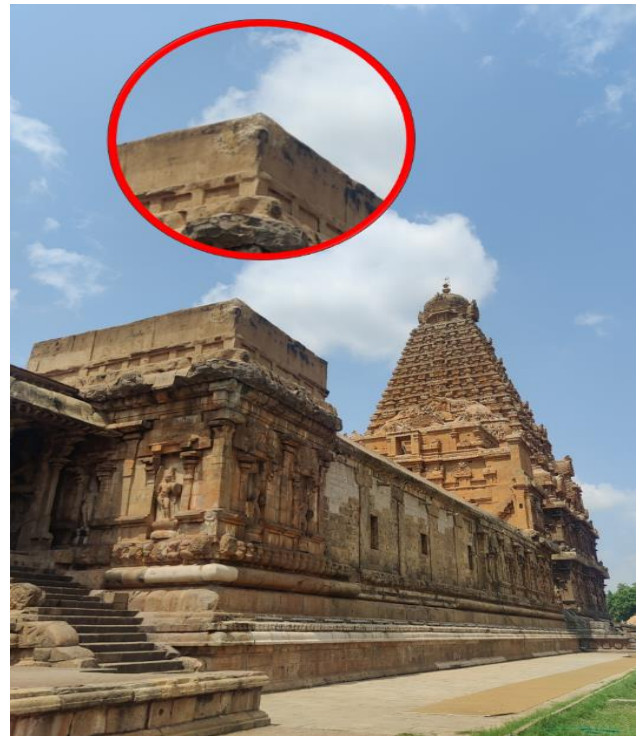
The air termination system is not visible on the main gate although there are down conductors running down both sides to three earth pits. The Down conductors have directly been clamped to the wall and have multiple steep bends. The Earth pit consisted of a GI pipe as an earth electrode.

Whereas, on the main temple building an air Termination System has been installed which is a conventional type that was clamped to the steeple of the temple. There is a lamp on a stand that was placed higher than the tip of the air termination. Two down conductors are taken almost together (at a few centimetre separation). A large number of acute bends on the down conductors can be observed. The copper strip has directly been brought into the ground and no earth pits were observed.

Figure 7: A Photograph of Brihadeeshwara temple located at the bank of the Cauvery river in Tamilnadu India. Shown in the inset is the edge of the temple that was struck by lightning.

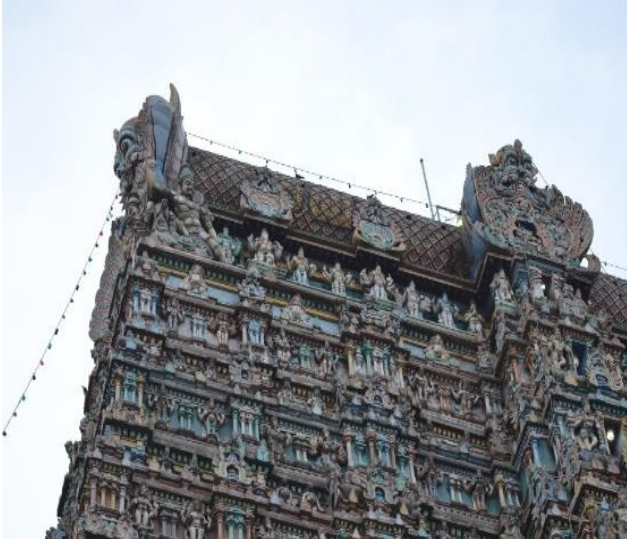
The Meenakshi Amman Temple is located in Madurai Tamilnadu India. It has four large gates in four geographic directions and the main temple building at the middle of the four gates. Each of the 5 structures has an air termination system and all of which are ESE types (Figure 8). However, no down conductor was visibly attached to the ESE air terminals. As these structures are built centuries ago, there is no possibility that they have a steel reinforcement structure to which the air termination could be connected. No earth termination system could also be seen in the vicinity of the structures.

Figure 8: Meenakshi Amman temple located at Madurai Tamilnadu India. An air termination system can be seen on the top of the building.

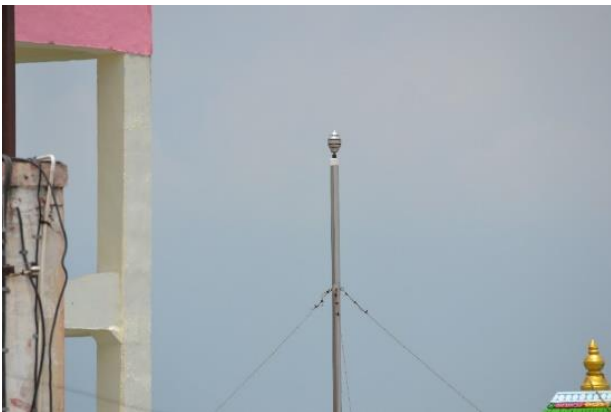
A lightning protection system has been installed on the temple. A single ESE was present on the top of the temple, however, no down conductors were observed (Figure 9). No earth termination system could also be seen around the temple.

An ESE type air terminal was also present close to the entry point of the temple which is at the height of the foot of the temple, with one down conductor touching the ground.

Figure 9: A Photograph of the ESE air termination system installed close to the entrance gate and well below the top of the structures in the close vicinity.

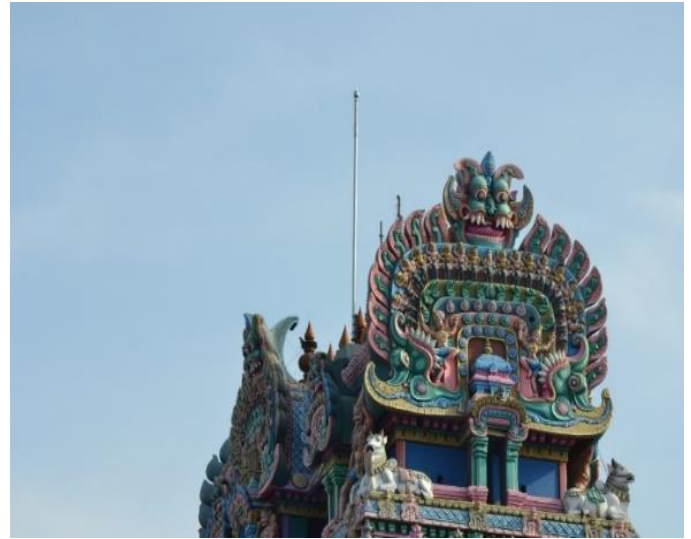
Thiruvanaikaval temple is a famous Shiva temple located in Trichy Tamil Nadu India. This is a large temple in terms of Area, with quite a few Structures. Out of the Temples inside Thiruvanaikaval, 4 temples have ESE type air termination systems (Figure 10). The remaining Temples did not have any type of LPM. The down conductors were mostly run down on two sides. The down conductors were Either single core cable or Copper Strip. The single-core cables were cut off halfway

to the earthing. The Earthing System is a tripod earthing system or G.I pipe, which is completely non-functional in 3 places since down conductors have been cut off in between.

Figure 10: The ESE air termination system installed on the top of the building of Thiruvanaikaval temple.

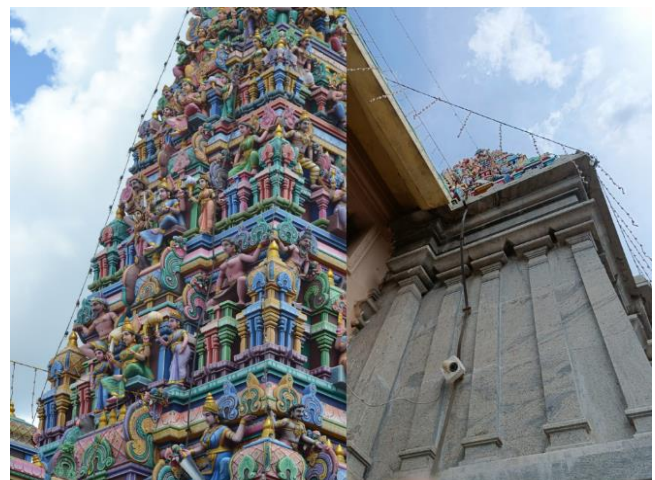
An alternative air termination rod, apparently an ESE device, is installed on the Front gate, whereas the down conductors were not visible nor were the earth termination visible.

Similarly, a conventional type of air termination system is seen to have been installed on the back gate of the temple, whereas, only one down conductor was seen to have been installed. Interestingly, on the down conductor CCTV camera is seen to be fitted (Figure 11).

On the other hand, there was no additional earth termination system instead and the down conductor strip itself has been earthed.

Figure 11: The down conductor system, on which CCTV was installed on the building of Samayapuram temple.
