Archaeological sites in Nepal and India: Concerns of lightning risks

Keywords—Archeological sites, lightning damage, non-standard LPS, South Asia

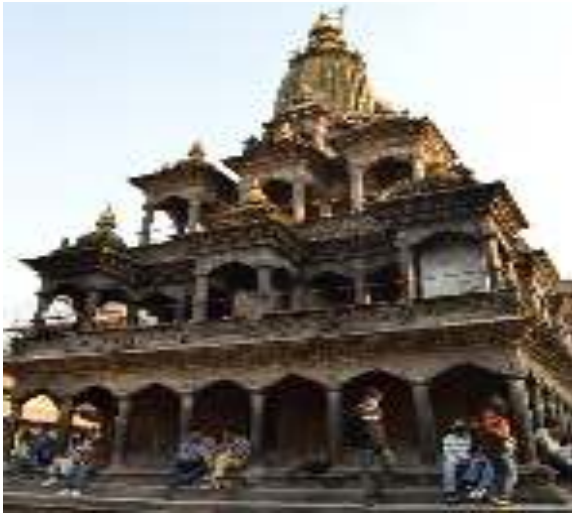
The Patan durbar square itself is a constituency of multiple archaeological structures among which the famous Krishna mandir and Patan museum are also present. None of the Structures built in the Durbar Square Premise has any form of

LPS, but some do have down conductor-style metallic strips hanging atop the structure (Figure 1).

Figure 1: Krishna Mandir (Lord Krishna's temple) built on the premise of Patan Durbar square that has an air termination steeple on the top that is not connected to a down conductor system or an earth termination (to be witnessed).

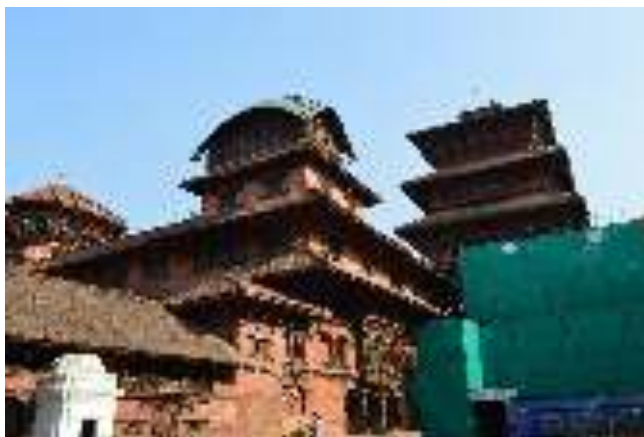
The Basantapur Durbar area is also a constituency of multiple archaeological structures, among which the famous Shiva Parvati temple and Hanuman Dhoka are also present. None of the Structures Present in the Durbar Square Premise has any form of LPS, but some do have a down conductor style metallic plate hanging atop the structure, except for one of the structures in the Patan durbar square. However, a lightning arrester followed by a single down conductor can be seen on Basantpur tower- a nine-storied structure that is being reconstructed after it was destroyed by the massive 2015 earthquake (Figure 2). Although a multinational company has been rebuilding the tower, none of the workers could explain the LPM being adopted. The Basantapur Durbar Square is located at the heart of Kathmandu, where there are dozens of archaeological structures but none of them seems to have proper LPM installed.

Figure 2: Basantapur tower that is being recently rebuilt after it was demolished by the 2015 massive earthquake. It can be seen on the tower that a single lightning air termination system followed by a single down

conductor is installed on it. We were not allowed to assess the base of the structure citing security reasons.

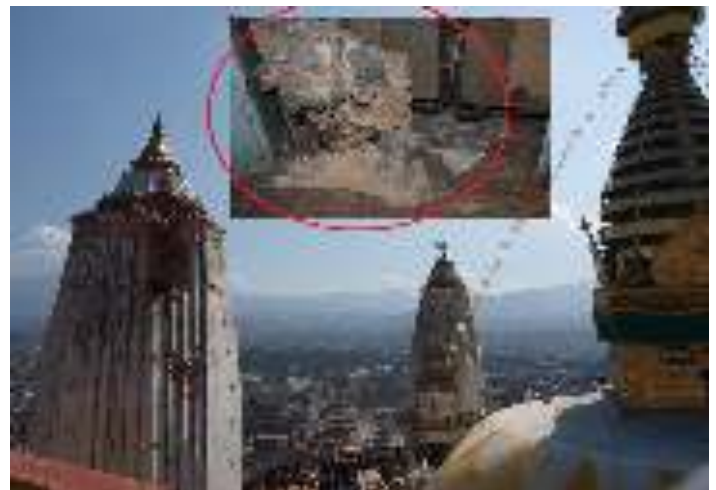
Among them, the Pratappur temple was struck and destroyed by lightning on 13th February 2011. Shown in figure 3 is a photograph of a damaged temple taken on the next day it was struck. Pratappur temple was destroyed by lightning sparing the taller structure since it did not have proper lightning protective measures. No appropriate lightning protection measures can be seen on the structure even though it was recently built (Figure 4).

Figure 3: The damaged Pratappur temple at Swyambhunath along with the main stupa and Anantapur temple. Also, shown in the inset is the damaged stone statue that was placed on one side of the main entrance door of the damaged temple.

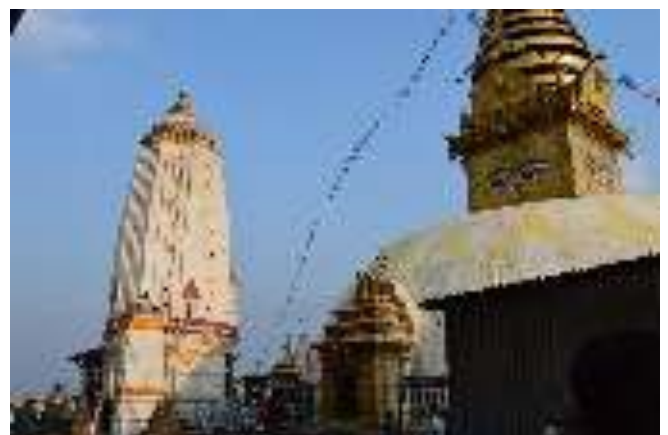
Instead, it is claimed by the local priest that LPM was done within the building after it was erected. Whereas,

- There was no visible air terminal on any of the structures.
- No available down conductors on either of the temple.
- No earth termination system could be observed.

Figure 4: The newly constructed Pratappur temple after it was destroyed by lightning in 2011.

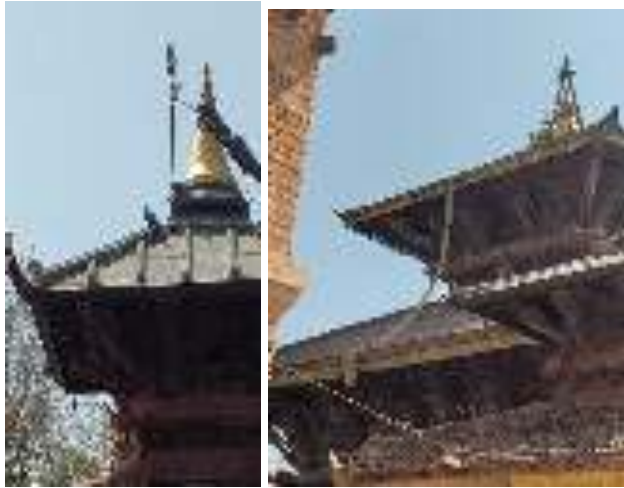
No protective measures against lightning have been taken as it is believed that the gajur (steeple) of the temple itself protects it from lightning. This temple is also a UNESCO world heritage site that is located atop a small hill to the north of Bhaktapur (Figure 5).

Figure 5: Changu Narayan temple located atop a small hill at Bhaktapur. The photograph on the left depicts an air termination system whereas the photograph on the right depicts the down conductor dangling towards the bottom edge of the roof.

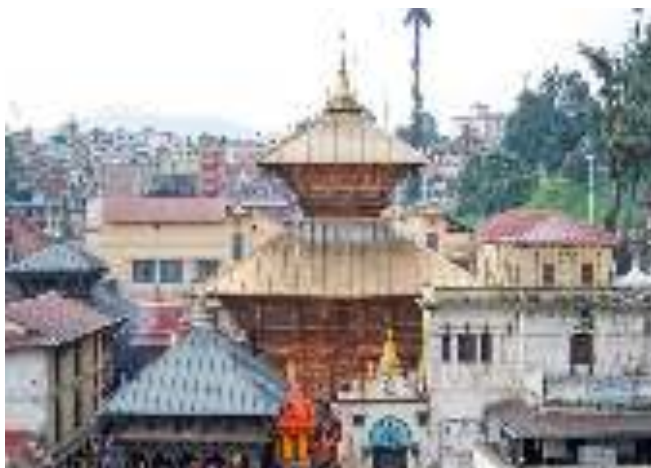
This temple is a sacred Hindu temple classified as a UNESCO world heritage site in 1979 that is believed to have been built in 400 BCE. Despite its historical and religious importance, no appropriate protective measures have been taken. It is believed that the metal steeple and the gold-plated metallic roof protect the temple from lightning (Figure 6). In this temple too, there is a trailing metallic strip that runs from the steeple and dangling below the roof.

Figure 6: Pashupatinath temple located at the bank of Bagmati river in Kathmandu. The steeple and the metallic roof are seen in the photograph.

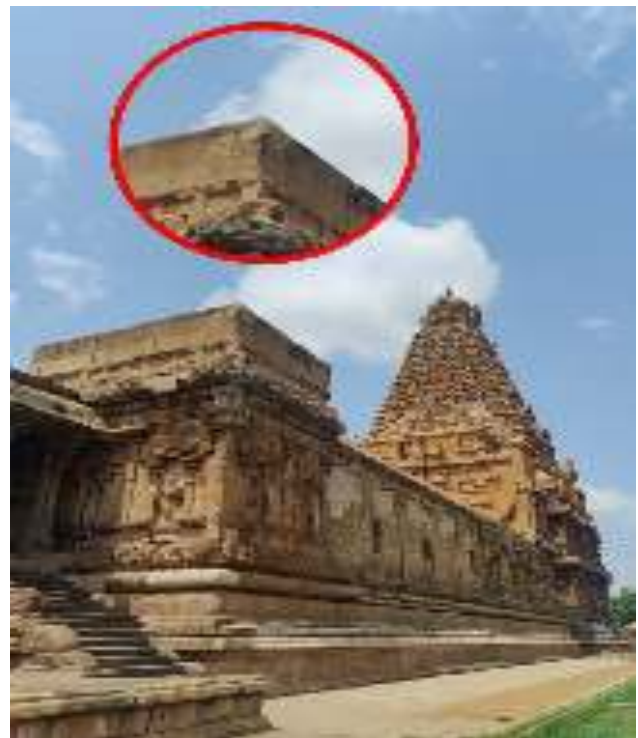
The air termination system is not visible on the main gate although there are down conductors running down both sides to three earth pits. The Down conductors have directly been clamped to the wall and have multiple steep bends. The Earth pit consisted of a GI pipe as an earth electrode.

Whereas, on the main temple building an air Termination System has been installed which is a conventional type that was clamped to the steeple of the temple. There is a lamp on a stand that was placed higher than the tip of the air termination. Two down conductors are taken almost together (at a few centimetre separation). A large number of acute bends on the down conductors can be observed. The copper strip has directly been brought into the ground and no earth pits were observed.

Figure 7: A Photograph of Brihadeeshwara temple located at the bank of the Cauvery river in Tamilnadu India. Shown in the inset is the edge of the temple that was struck by lightning.

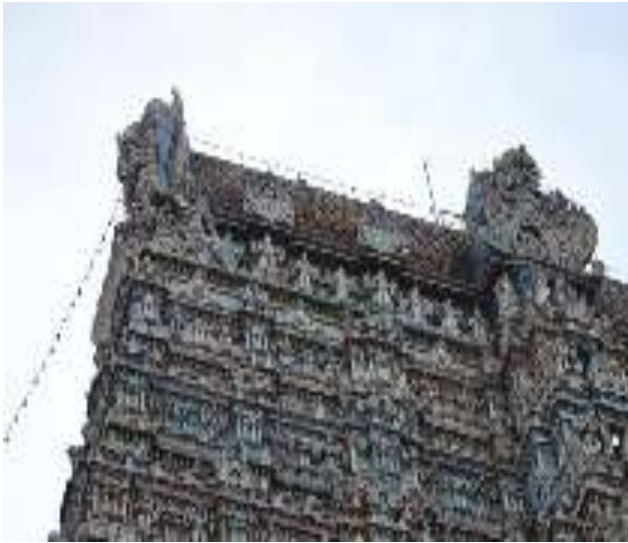
The Meenakshi Amman Temple is located in Madurai Tamilnadu India. It has four large gates in four geographic directions and the main temple building at the middle of the four gates. Each of the 5 structures has an air termination system and all of which are ESE types (Figure 8). However, no down conductor was visibly attached to the ESE air terminals. As these structures are built centuries ago, there is no possibility that they have a steel reinforcement structure to which the air termination could be connected. No earth termination system could also be seen in the vicinity of the structures.

Figure 8: Meenakshi Amman temple located at Madurai Tamilnadu India. An air termination system can be seen on the top of the building.

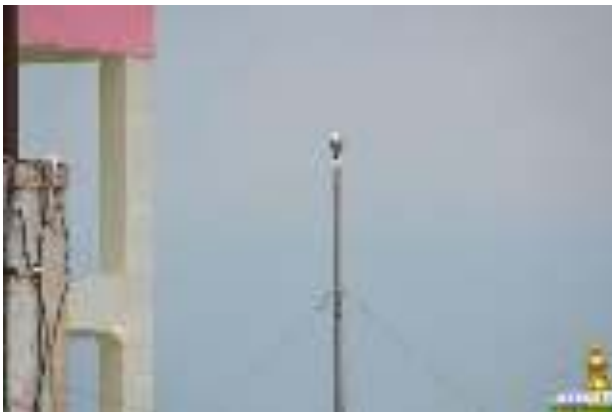
A lightning protection system has been installed on the temple. A single ESE was present on the top of the temple, however, no down conductors were observed (Figure 9). No earth termination system could also be seen around the temple.

An ESE type air terminal was also present close to the entry point of the temple which is at the height of the foot of the temple, with one down conductor touching the ground.

Figure 9: A Photograph of the ESE air termination system installed close to the entrance gate and well below the top of the structures in the close vicinity.

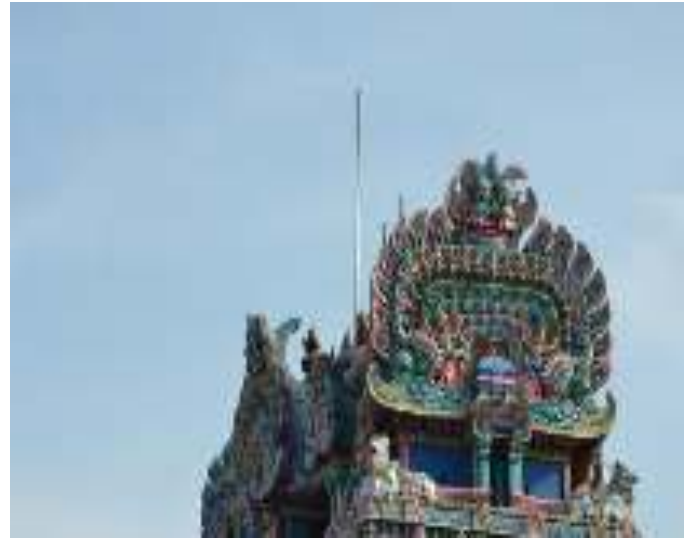
Thiruvanaikaval temple is a famous Shiva temple located in Trichy Tamil Nadu India. This is a large temple in terms of Area, with quite a few Structures. Out of the Temples inside Thiruvanaikaval, 4 temples have ESE type air termination systems (Figure 10). The remaining Temples did not have any type of LPM. The down conductors were mostly run down on two sides. The down conductors were Either single core cable or Copper Strip. The single-core cables were cut off halfway

to the earthing. The Earthing System is a tripod earthing system or G.I pipe, which is completely non-functional in 3 places since down conductors have been cut off in between.

Figure 10: The ESE air termination system installed on the top of the building of Thiruvanaikaval temple.

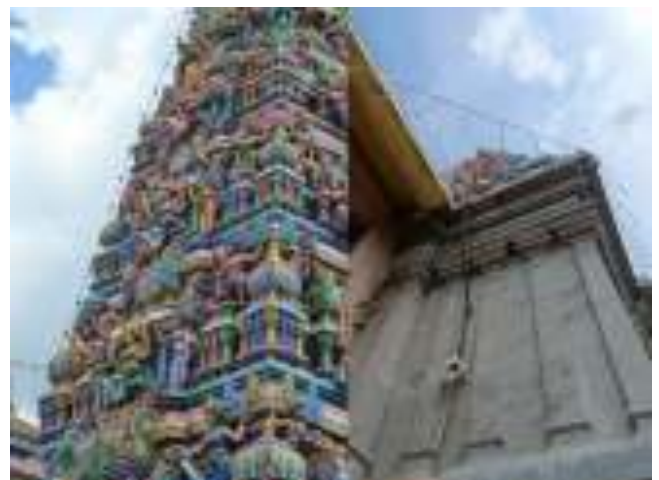
An alternative air termination rod, apparently an ESE device, is installed on the Front gate, whereas the down conductors were not visible nor were the earth termination visible.

Similarly, a conventional type of air termination system is seen to have been installed on the back gate of the temple, whereas, only one down conductor was seen to have been installed. Interestingly, on the down conductor CCTV camera is seen to be fitted (Figure 11).

On the other hand, there was no additional earth termination system instead and the down conductor strip itself has been earthed.

Figure 11: The down conductor system, on which CCTV was installed on the building of Samayapuram temple.

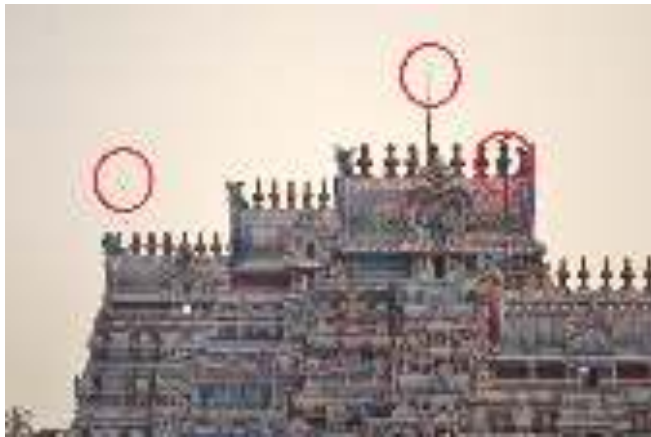
Out of the 21 temples, 12 have been installed with ESE air terminals (Figure 12), whereas, the remaining 9 temples do not have LPM.

Each of the 12 air terminals had a single down conductor each running directly into the earth without proper pits or earth termination system.

Figure 12: Three ESE air termination systems installed on the top of the buildings at Srirangam temple.
