TECHNICAL BROCHURE

HVDC transformer failure survey results from 2013 to 2020

Reference: 859

December 2021

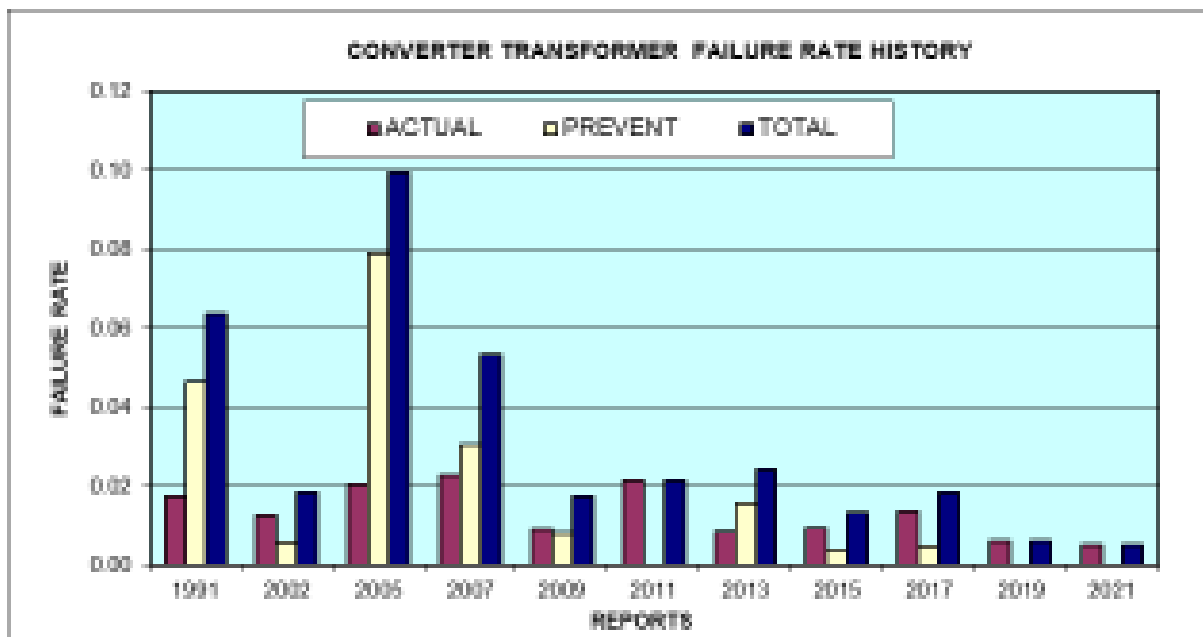
Figure 7-1- Failure Rate for the period 1972 to 2020

It can be observed in Figure 7-1 that following a reduced failure rate in the period from 1991 to 2002, there was a significant increase in the period from 2003 to 2006 (2005 and 2007 report). The failure rate in last three reports (2009 to 2019) decreased to same level as the rate recorded for the period 1991 to 2002. Failure rate in 2019 and 2021 reports is less than 0.006. In addition majority of these failures are on systems more than 25 years old.

This finding is encouraging, indicating a potential effect of the latest version of the IEC 61378-3 [6] standard as well as a strong action that followed an upsurge of the HVDC Converter Transformers caused to a full or a partial extent by corrosive oil.

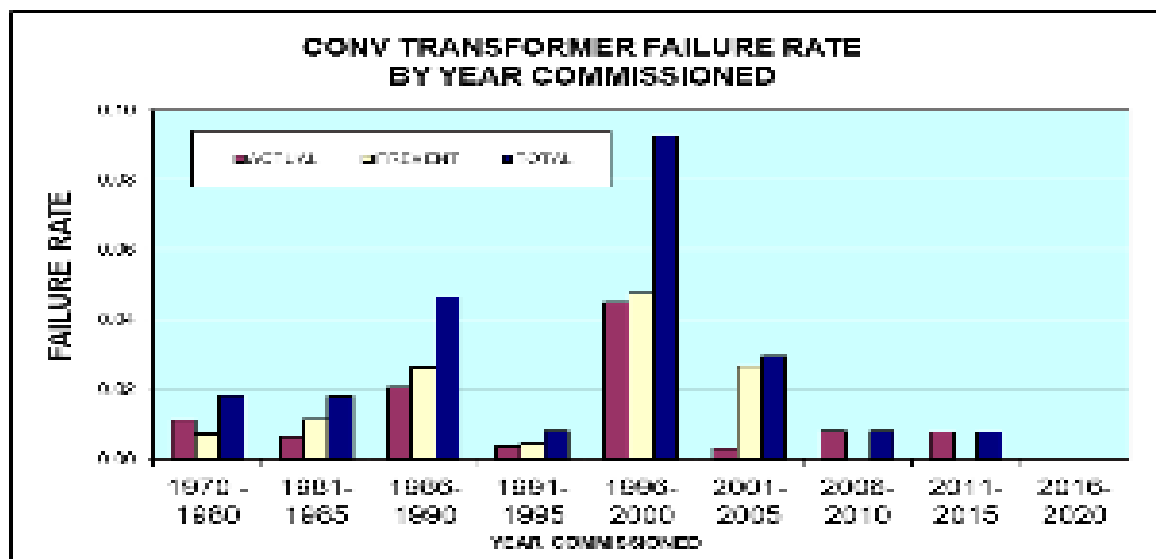
Figure 7-2 - Converter Transformer failure rate by year of commissioning

For systems installed between 2001 and 2010, the preventive failure rate is slightly higher than the actual failure rate. This phenomenon could be attributed to the following;

- Modern transformers are now more closely monitored (e.g. on-line gas monitoring).
- Most of the systems are designed with spare transformers being readily available so that when a potential problem occurs the unit can be changed before the actual failure.

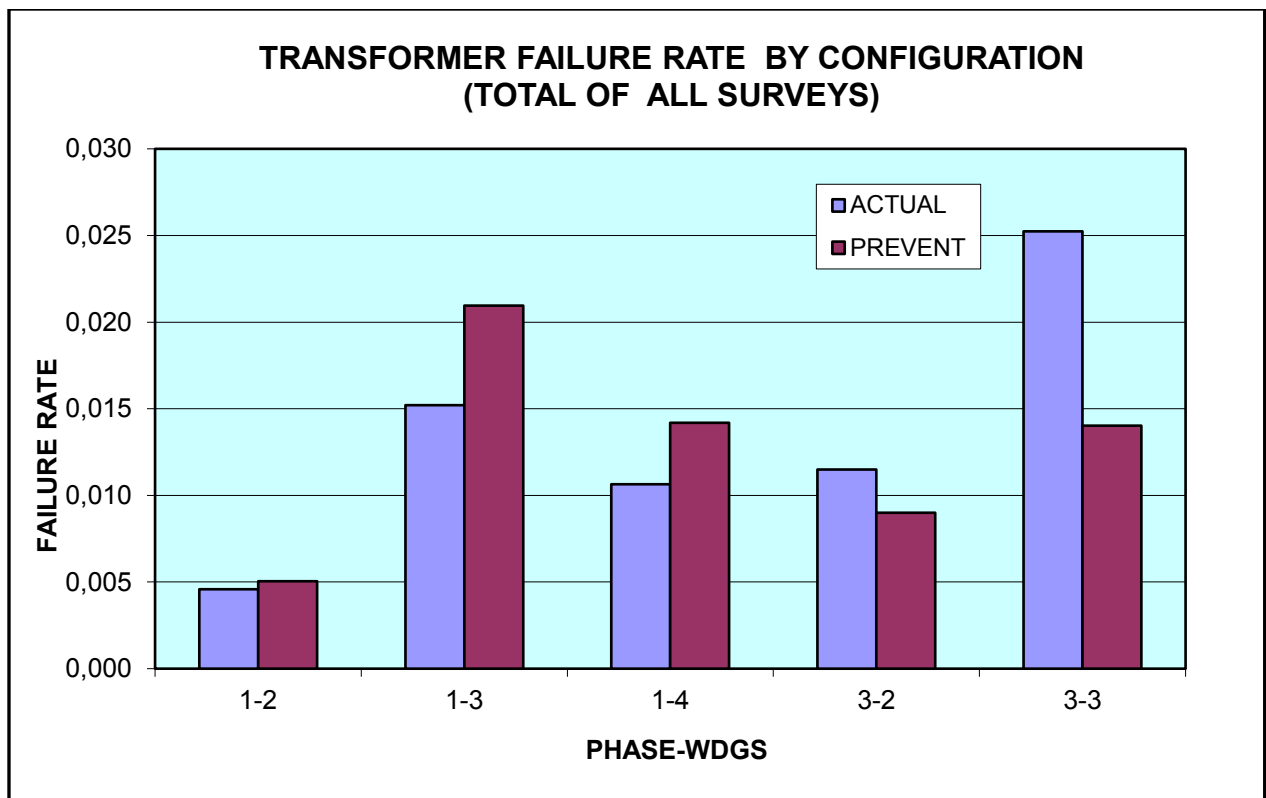
Figure 7-3 - Failure rate of transformers by configuration

Figures 7-3 and 7-4 show that **most failures occurred in single phase units containing line winding and star and delta valve windings**. These transformers were of the ratings 275 MVA and above and installed in the HVDC systems of 500 kV or above. This increased failure rate could be associated with the complex winding insulation and lead exit design.

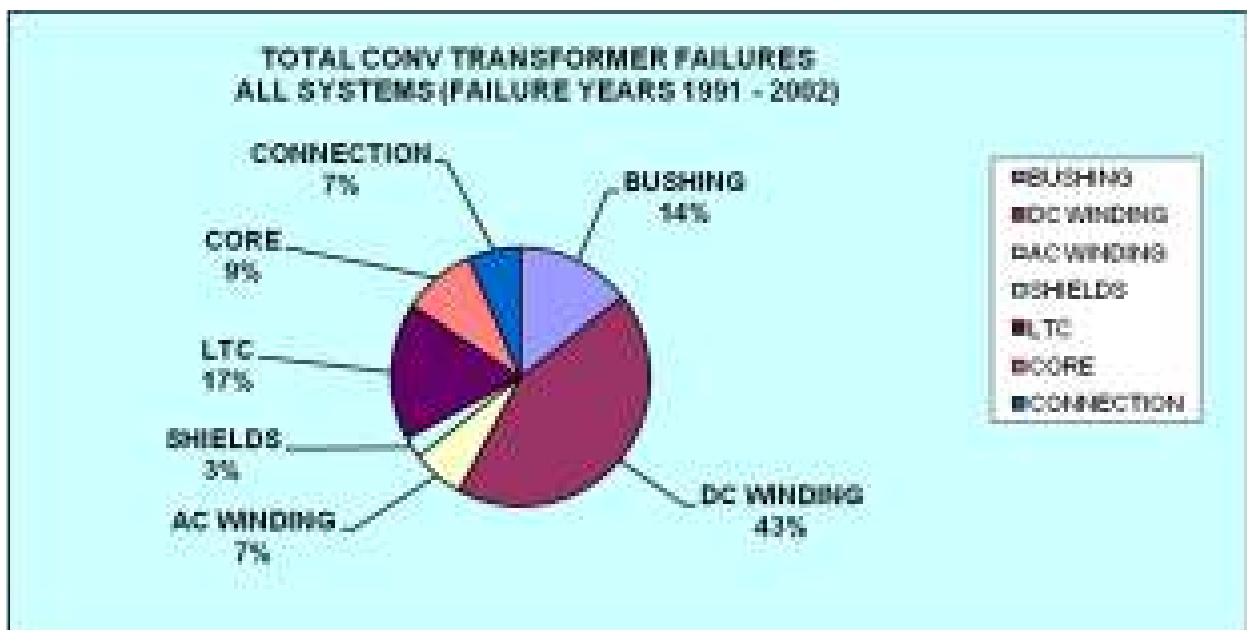
Figure 7-6 – Failure by component 1991 to 2002

Figure 7-6 show all failures reported in JTF B4.04/A2-1 report [2] from 1991 to 2002. The three major causes of failure during this period were as following;

DC winding	43%
Tap Changer	17%
Bushing	14%

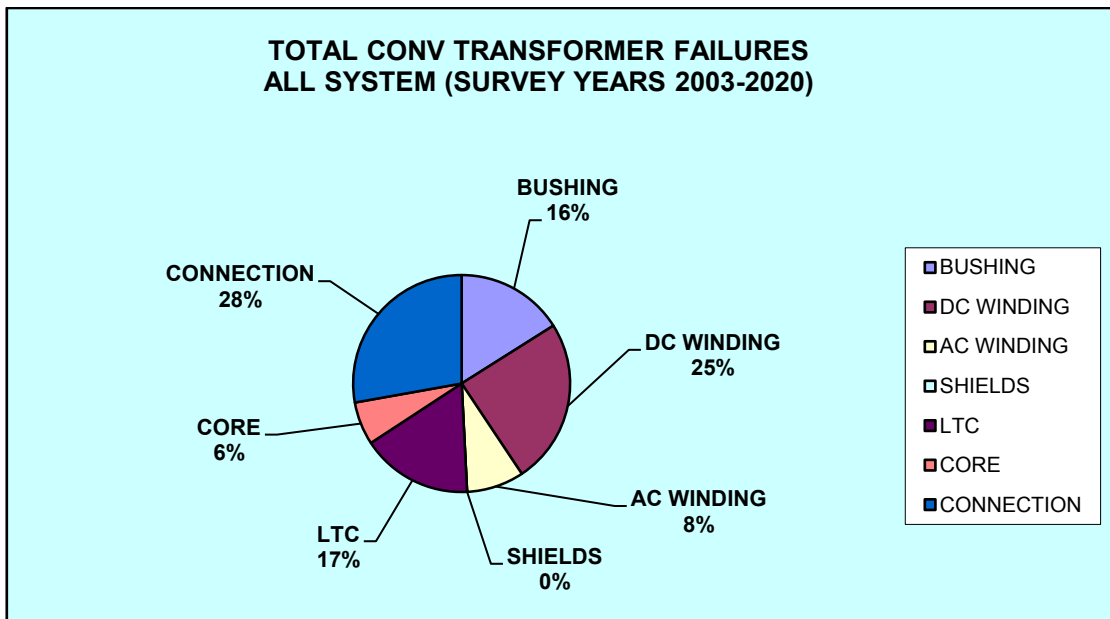
Figure 7-7 – Failure by component 2003 -2020 (All systems)

Figure 7-7 shows the total failures (actual and preventive) by components, for the period from 2003 to 2020 (combined). Figure 7-7 includes all the systems that reported irrespective of the year of installation.

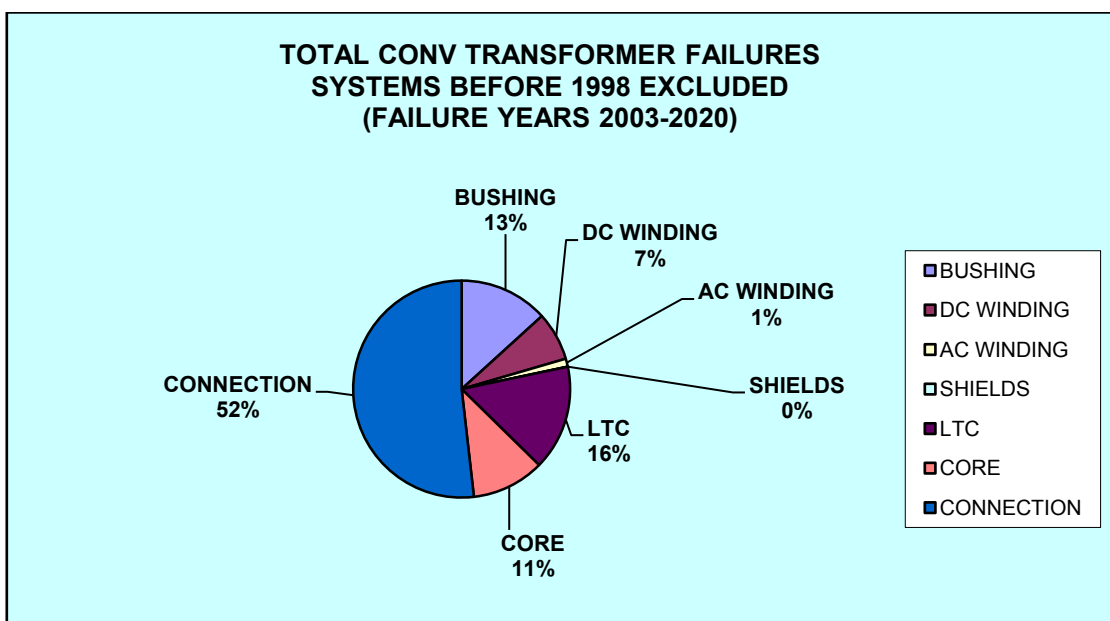
Figure 7-8 - Failures by component 2003-2020 excluding systems commissioned before 1998

Figure 7-8 shows the total failures (actual and preventive) by component for the systems installed in 1998 or later. The percentage failures by components are as following

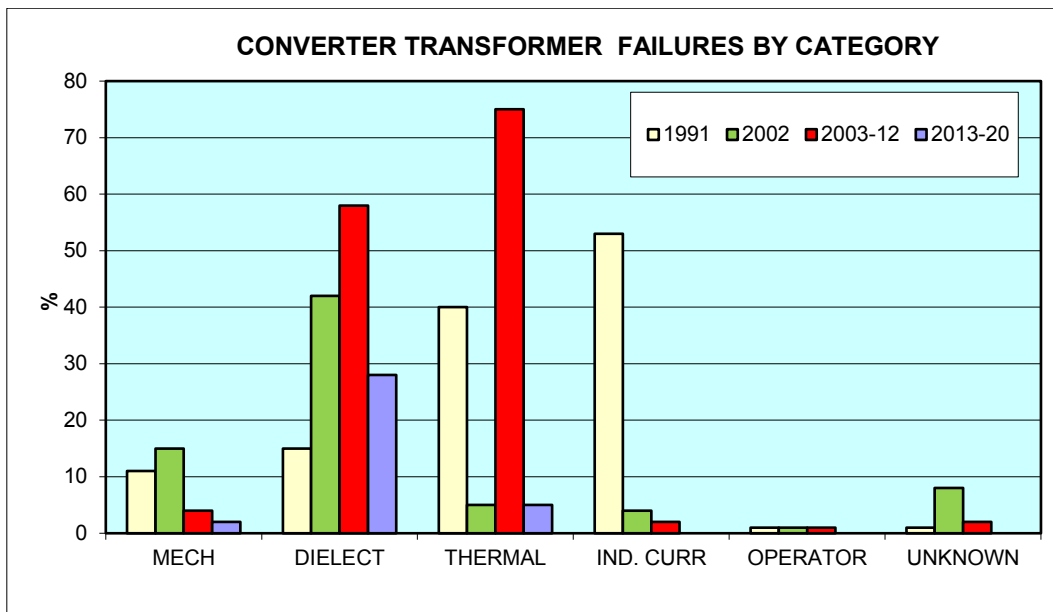
Figure 7-9 – Probable cause of failures

Figure 7-9 shows that following the recommendations of JTF 12/14 10-1, the failures due to induced current have been successfully mitigated. The mechanical failures are mostly related to bushings and LTCs. The dielectric and thermal failures continue to be the two dominant causes. For systems commissioned after 1998 the failures in the connections (figure 7-8) are mostly due to thermal overheating (figure 7-9).

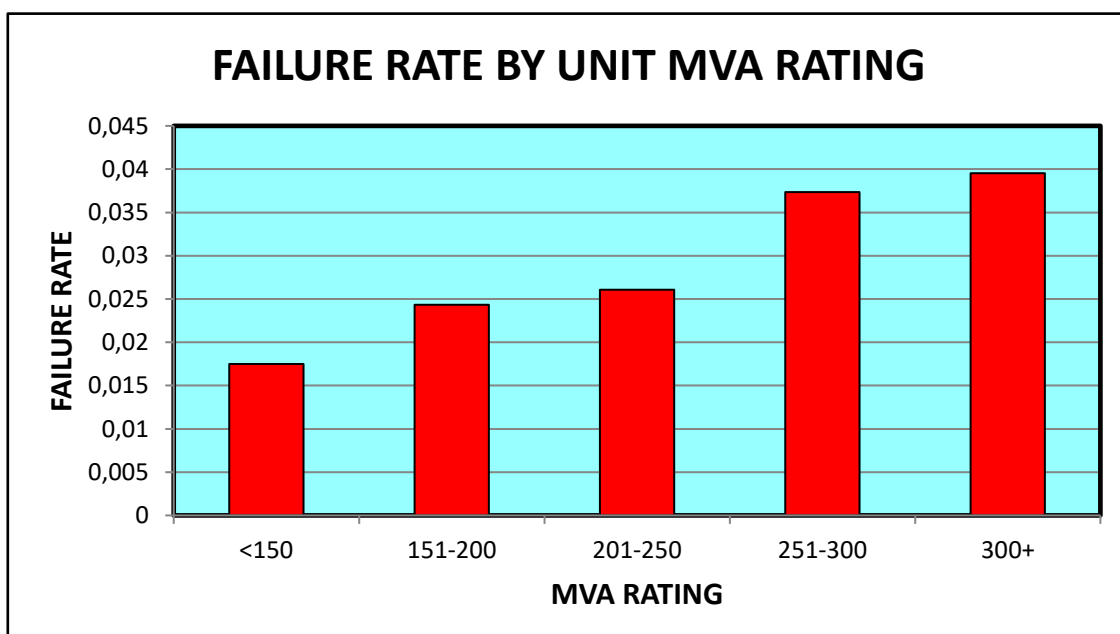
Figure 7-10 - Failure rate by unit MVA rating

Figure 7-10 shows the failure rate of converter transformers as a function of unit MVA rating. The failure rate increases as the unit rating increases. Higher rating presents a challenge of keeping the dimensions as small as possible for transportation reasons and at the same time meet all the electrical clearances and provide sufficient cooling of all the parts.
