# Improper System Earthing : Loss of Production, Busting of Power Cable and Power Transformers

11 kV Power Bus with 4 Source, Delta Connected Power TR and R Earthed TGs

Presenting here, one such incident which leads to Too many Blackouts, and Failure of 25 MVA, 132/11, Ynd1, Power Transformer twice within a span of 2 years.

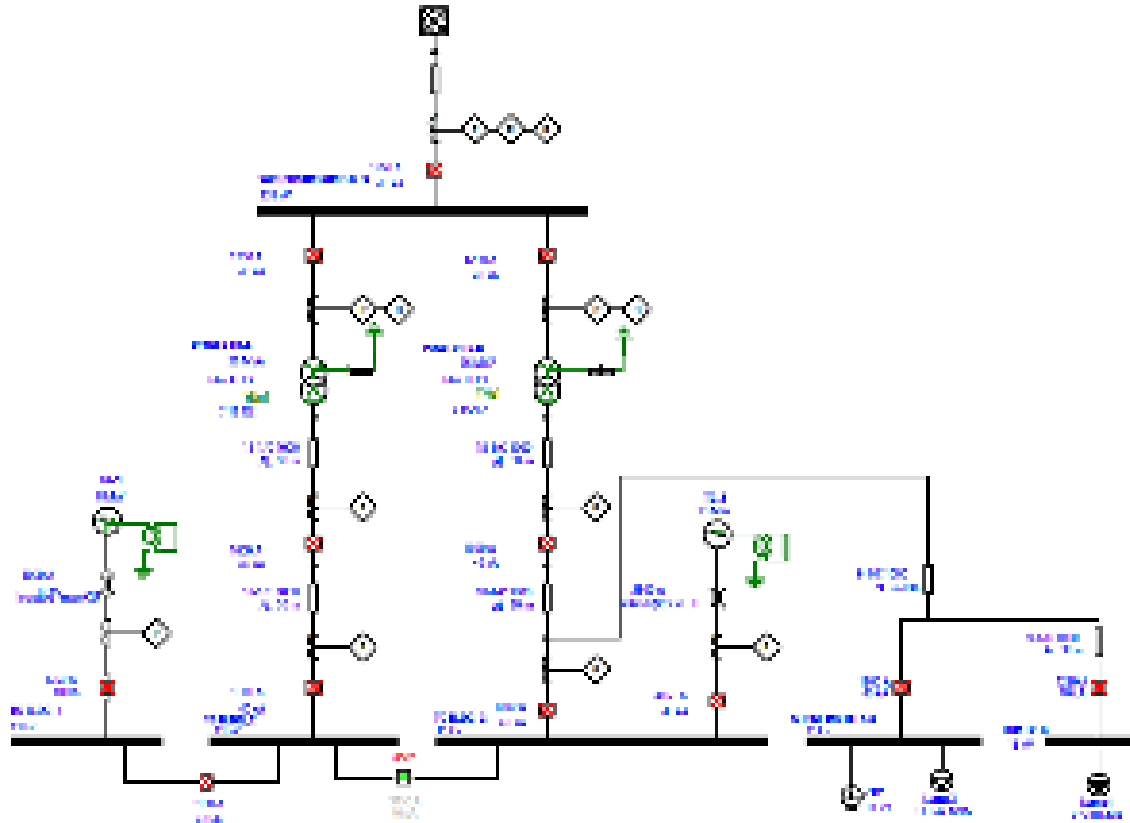
As we can observe in shown SLD, all the 4 sources were clouded and highlighted in **RED** on 11 kV Bus.

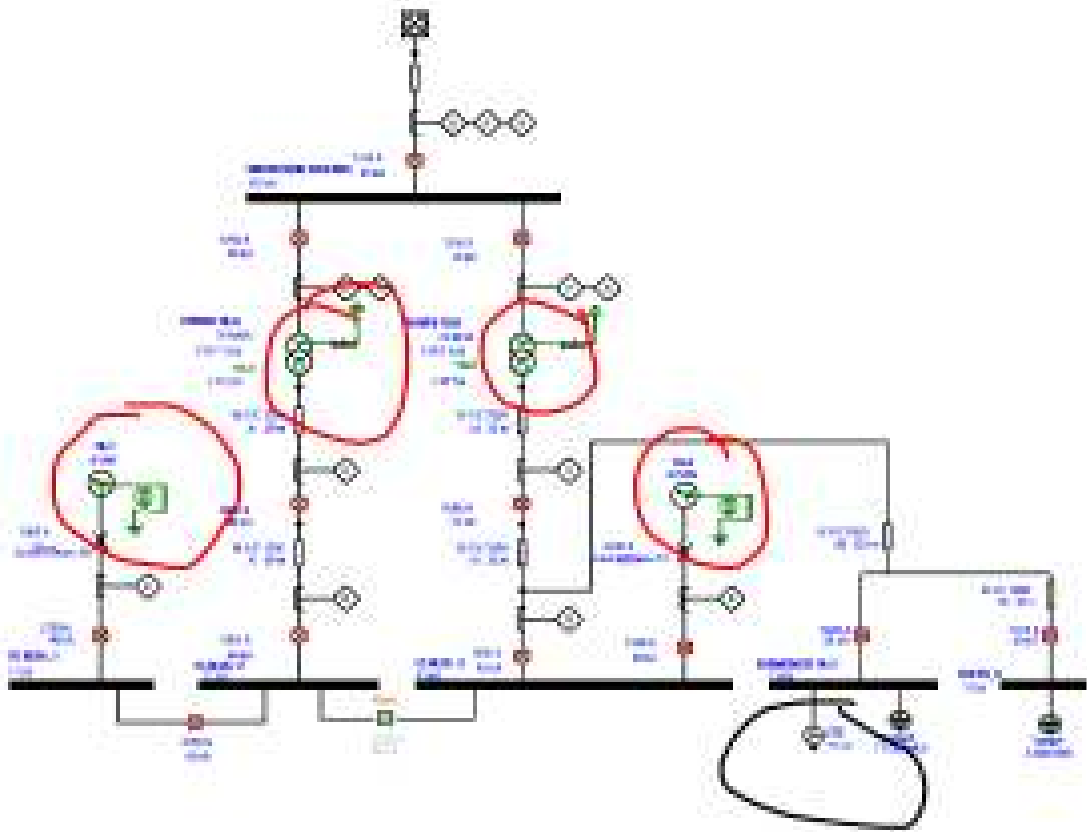
- There are two NGR with TG-1 and TG-2 limiting to fault current at 100 A on 11 kV.
- Earthing Transformer was also available in 11 kV circuit network, limiting to fault current at 100 A, it is clouded in **BLACK**, shown in SLD above.

Now in Circuit - 2, due to problem in VCB of required Earthing Transformer was kept open and isolated, since complete 11 kV System was earthed through NGR of TG only for circuit – 2 as illustrated in fig. below :

It was recommended to keep Earthing Transformer always in line so as to avoid system in floating during Is-landed condition.

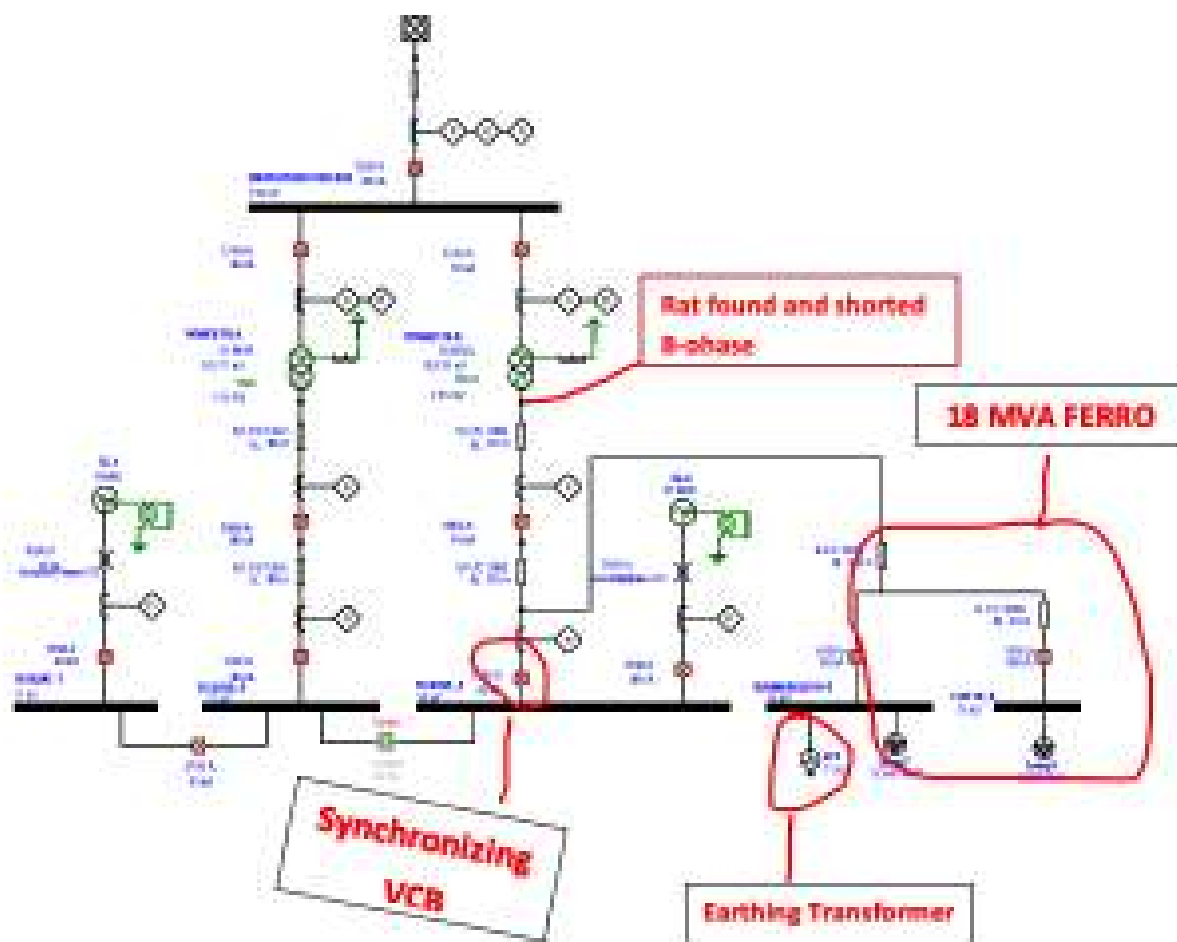
- Now, Plant was running on maximum capacity, with TG synched with Utility.
- Earth Fault occurred on secondary side of Power Transformer, i.e. Rat entered and shorted B-phase with ground as we can see it in figure.

- 2 source ( Utility and TG) were contributing to the fault, however return path to the fault was through Neutral of Generator only.
- Amid higher setting of Relay at Synchronising Breaker, Relay at TG issued Tripping command and TG was isolated from system.

- However, fault in the system was still uncleared as it was being fed by Utility.
- Also, due to isolation of TG, complete 11 kV system became un-earthed (Floating).

- Now, though there was a B-Earth fault, but return path to the fault was not available, circuit was incomplete and fault remained un-cleared.
- Now this would continue till second puncture occurs and circuit gets completed and Phase – Phase occurs for delta system.

- Also, due to single Phase-Earth fault on delta side, there was no reflection on primary side of Transformer.
- Amid, lasted fault on secondary side, it created voltage stress in winding and leads to **Winding Failure of Transformer**.

- System was Grounded through only NGR of TG.
- Relay setting of Relay at Synched Breaker was raised higher and was not Reverted to original, leads to Tripping of TG Relay and leading to Un-earthed (Floating ) System.

- Since, second source was utility, and B Phase - Earth fault was persisting but was not getting path to complete the circuit.
- Due to uncleared fault, there was a voltage stress and it remained for such a long duration, that it leads to failure of Transformer winding.
- Now, this was not due to one-time fault, but every time whenever earth fault has occurred during Un-earthed condition, it has remained in system until failure and/or black outs

- System Earthing at Source bus is of supreme importance
- There must be logic OR SOP for keeping Neutral grounded among available multiple NGR/NGT.
- Also, we can't keep all the NGRs in line, looking towards Generator Damage curve. So grounding of Neutral through NGR/NGT must be identified and planned to avoid any major issues.
