# Case Study - How Auxiliary Contactors mounting may result into Mal-operation & hence tripping of Equipment

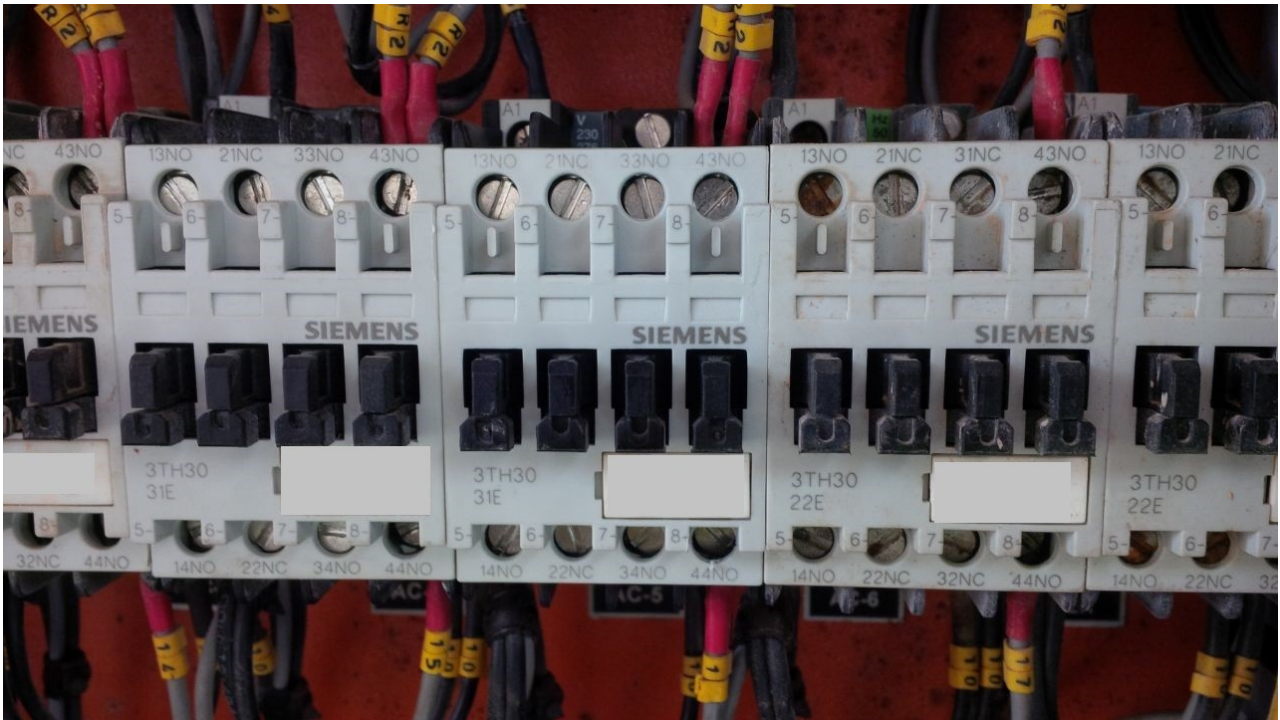
**Pic-1**

Many of you have seen position of Auxiliary contactor inside your panel as shown in Below Pic-1 & 2.

Obviously, it is not necessary that all the contactors are ON at same time and it will never be. But yes 2-3 adjacent contactors can be ON simultaneously. This case happened in May2015.

Above auxiliary contactors were placed in one HT Panel which was used to start a Mill (Motor) in a process industry. After 3 years of commissioning of plant one HT panel got tripped. And what engineer found, that coil of Auxiliary contactor was burnt and hence it was not picking up and that feedback signal was not going to control room, ultimately resulting into tripping of that Motor and hence that section of the Plant.

And in 3-4 days team found the root cause. The temperature difference on Aux contactors between 2 panels was around 5-6 degrees. Actually, the minor heat which was generated when contactor was **ON**, was not able to dissipate properly due to no space between Aux contactors, and due to this heat generated by the contactors were accumulated there only and in the long run contactor coil was burning or contactor failing.

**They checked the same with Other HT panel too and yes temperature on contactors in Panel with some spaces between Aux contactors was on lower side compared to those with no space between Aux Contactor. The same was implemented across plant, as per the space available.**
