Case Study - How Auxiliary Contactors mounting may result into Mal-operation & hence tripping of Equipment

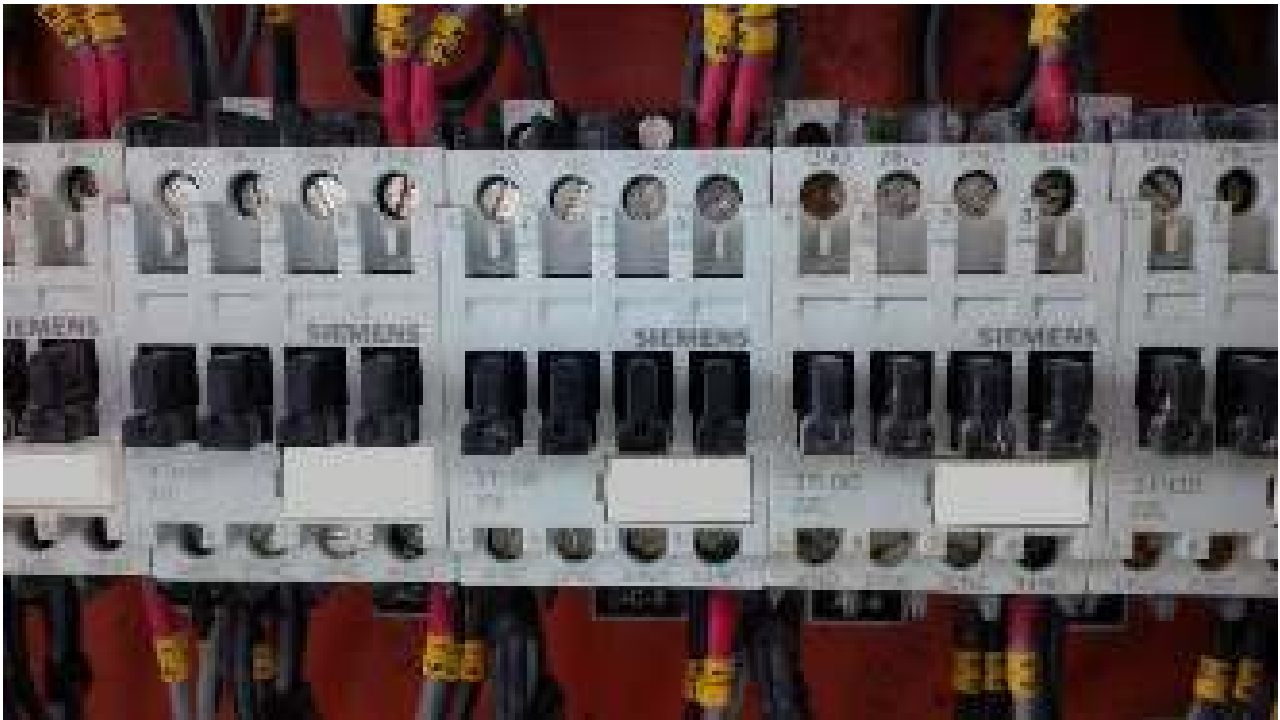
Many of you have seen position of Auxiliary contactor inside your panel as shown in Below Pic-1 & 2.

Obviously, it is not necessary that all the contactors are ON at same time and it will never be. But yes 2-3 adjacent contactors can be ON simultaneously. This case happened in May 2015.

Above auxiliary contactors were placed in one HT Panel which was used to start a Mill (Motor) in a process industry. After 3 years of commissioning of plant one HT panel got tripped. And what engineer found, that coil of Auxiliary contactor was burnt and hence it was not picking up and that feedback signal was not going to control room, ultimately resulting into tripping of that Motor and hence that section of the Plant.

And in 3-4 days team found the root cause. The temperature difference on Aux contactors between 2 panels was around 5-6 degrees. Actually, the minor heat which was generated when contactor was **ON**, was not able to dissipate properly due to no space between Aux contactors, and due to this heat generated by the contactors were accumulated there only and in the long run contactor coil was burning or contactor failing.

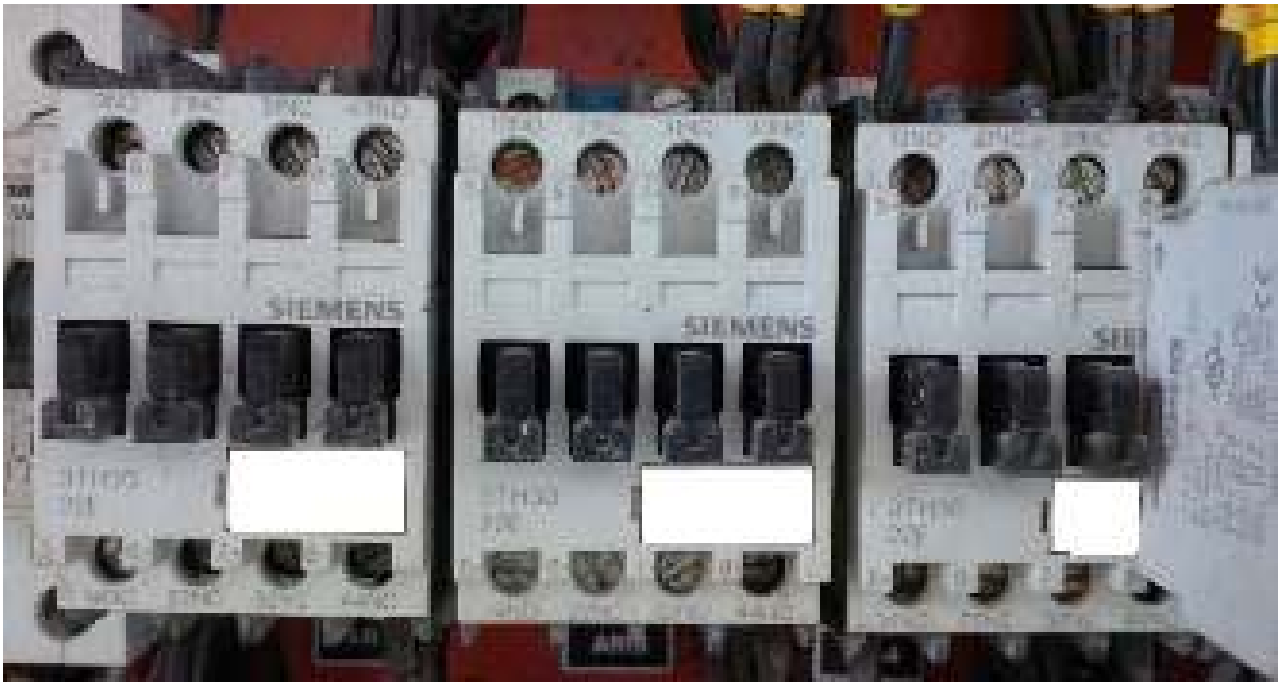
Pic -3

They checked the same with Other HT panel too and yes temperature on contactors in Panel with some spaces between Aux contactors was on lower side compared to those with no space between Aux Contactor. The same was implemented across plant, as per the space available.

Also, every plant has its own space problems in HT panels, but what we as a maintenance engineer found out that keeping a small space between Aux contactor is good in the long run. You too can try in your plant.
