TECHNICAL BROCHURE

HVDC transformer failure survey results from 2013 to 2020

Reference: 859

December 2021

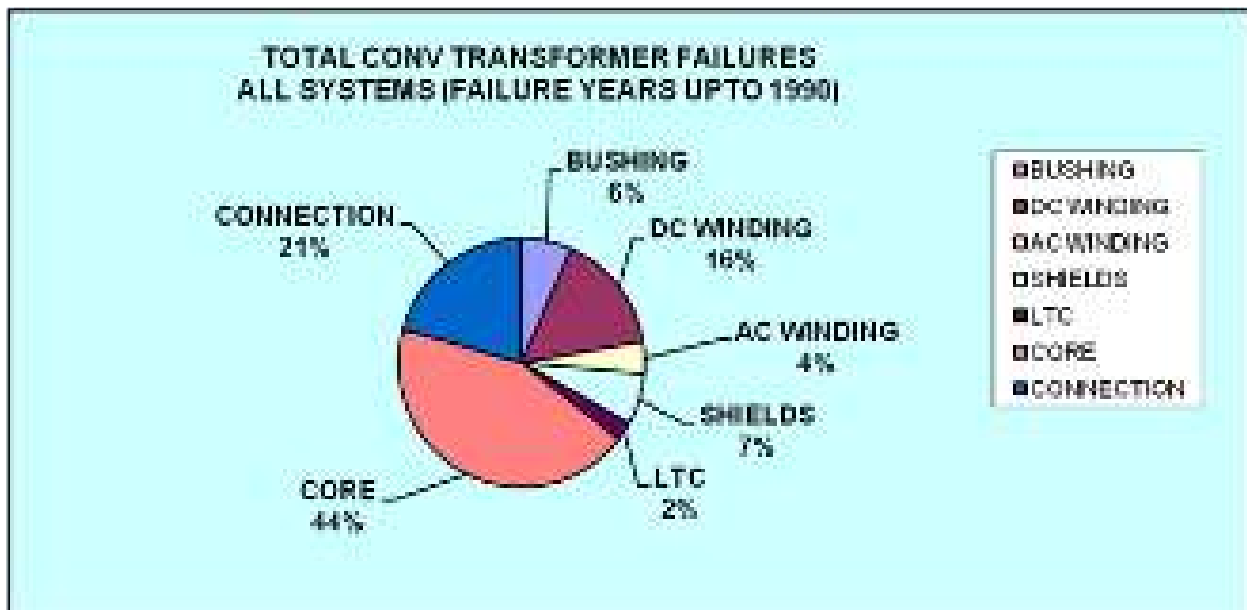
Figure 7-5- Failure by components up to 1990

Figure 7-5 show failures reported in JTF 12-14/10-01 report [1] up to year 1990. The three major causes of failure during this period were as following;

Core	44%
Connections	21%
DC winding	16%
