# Ubiquitous and Perplexing Proliferation of Non-standard Lightning Protection System in Developing Countries

**Abstract**—Human safety and protection of properties from lightning hazards have been a challenge in many developing countries in lightning dense regions for the last many decades. Perennial and deep-rooted myths, superstitions and the proliferation of non-standard lightning protection systems aggravate the situation. In this study, we have attempted to underscore various challenges that protection practitioners and scientists have been encountering in developing countries at present. The non-existence of national standards and guidelines, weak imposition of codes, in those countries, can be attributed to the failures in mitigating the loss of lives and damage to properties. The proliferation of non-standard lightning arresters, that are being professed as magical solutions, has obscured not only the public but also the engineering professionals hindering them from adopting scientifically proven mitigation measures. Moreover, the design and installation practices adopted for such arresters fail to follow any national standards despite their claims. Such practices not onl

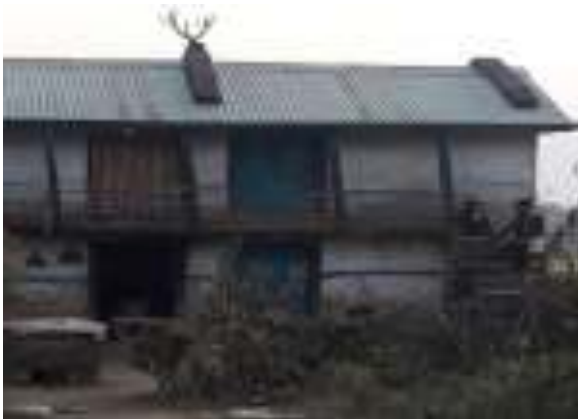
Figure 1: A photograph of cactus plant placed on the roof of common house in Nepal for averting lightning from striking the house.

a) Cactus trees are planted on the roof of a house during the house warming ceremony that is believed to protect the house.

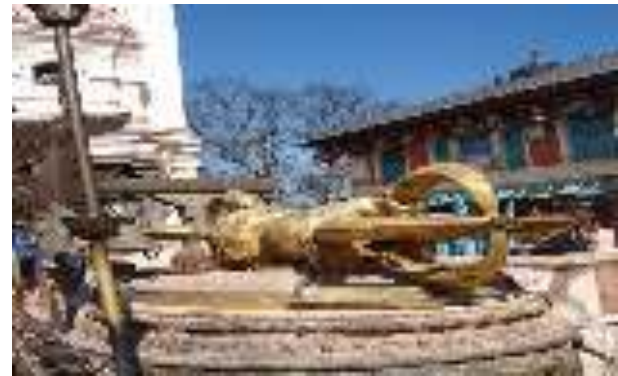
Figure 3: A photograph of Vajra (Dorje) placed on a pillar in front of a Swayambhunath Buddhist temple in Kathmandu Nepal. Note that the temple, partly seen next to the Vajra, was struck by lightning on 13<sup>th</sup> February, 2011.

c) Vajra (dorje) is placed on pillars in front of Buddhist temples with a belief that the thunderbolt is buried underneath and hence no lightning will strike the temple.

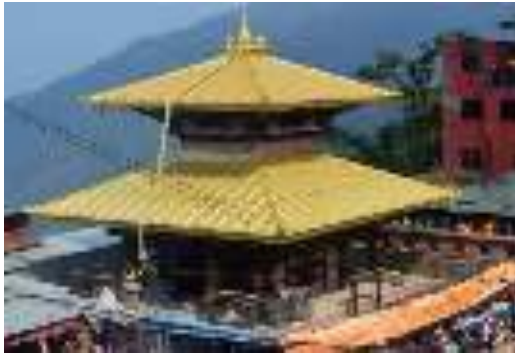
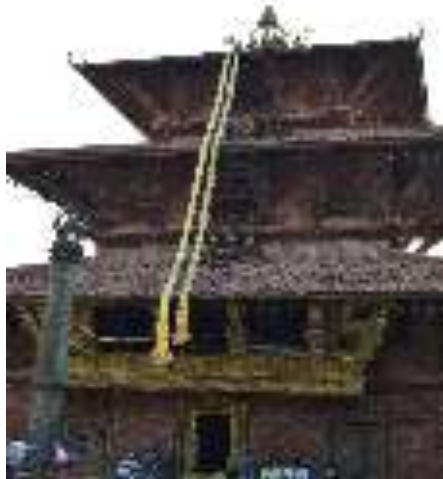
Figure 4: Photographs of: (a) Manakamana temple, some 80 km west of Kathmandu. The roof of the temple is gold plated with a metallic spire on the top (apparently an air termination system) being connected with a metal strip (apparently a down conductor). (b) Two metallic strips hanging from the roof and connected to the spire on the top of Bhimsen temple (built in 1680 AD) located in the premise of Patan Durbar square, Lalitpur Nepal.

Although the present-day scientific practices such as IEC 62305 could not be verified, there is some evidence on the 400 AD monuments (such as Pashupatinath temple in Kathmandu) that protective measures against lightning could have been adopted. Most of the temples across Nepal built during the same era or middle ages, are seen to have metallic sheets on their roof on the highest point of which, a metallic sword is erected and is connected with a metallic strip seen hanging well below the lower part of the roof even today. Such an installation along with earthing system could have been practised during that time, but the lack of the transformation of knowledge led such installations to be a mere decoration of the structures.

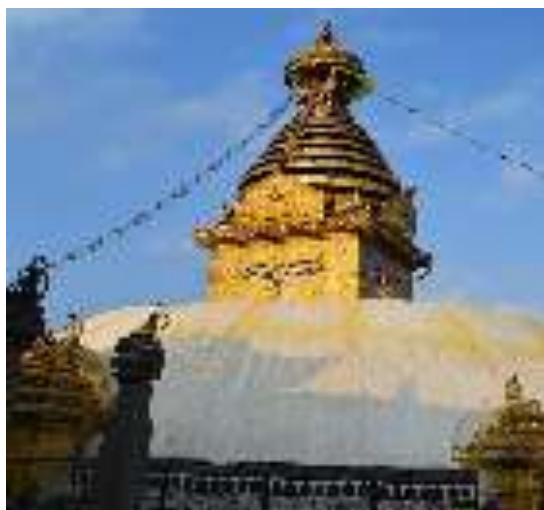
Figure 5: A photograph of Buddhist temple (stupa) at Swayambhunath, built atop a small rocky hill (around 640 AD) in the western part of Kathmandu Valley.

Similarly, the Buddhist temples/stupas built during the medieval period have large mettalic structrues towards the top of the structures.

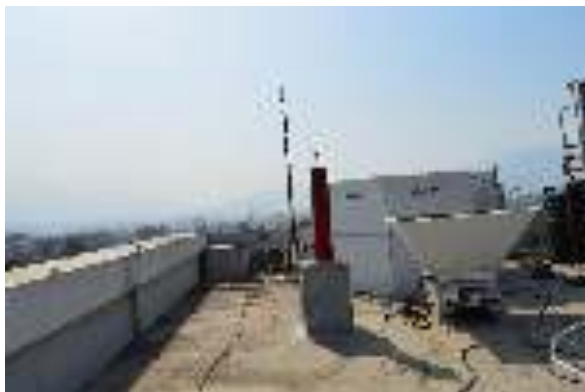
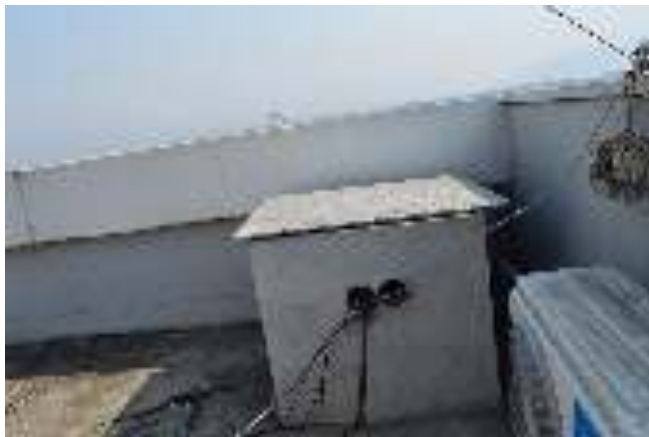
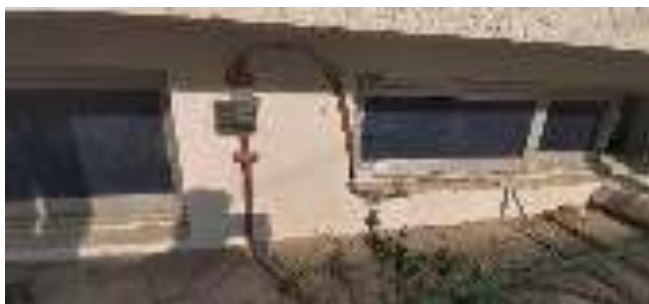
Figure 7: Photographs of (a) An ESE lightning air termination system positioned at a corner of the Department of Hydrology and Meteorology building, Babarmahal Kathmandu.

(b) A PVC raceway through which the down conductor has been dragged to the earth termination system through within the building.

(c) Down conductor dragged out of the building and fitted with lightning counter.

Such non-conventional lightning protection practices are often claimed to have been following the French standard (NFC 17-102) in order to get validation, though, the design and installation practices fail to comply with the claimed standard. Such installations have been observed at all the sites taken into account in this study in Nepal. An example of such installation can be seen in the photograph captured at the newly built building of Department of Hydrology and Meteorology (DHM) Nepal as is in figure 7. The new DHM building is about 40 m tall and ESE rod is placed towards a corner on the top floor of the building leaving the whole other section of the structure unprotected. Further, a copper strip

used as a single down conductor has been dragged through a PVC raceway within the structure as shown in figure 7 (b). Seen in the figure 7 (c) is the down conductor strip dragged out of the building through a window.

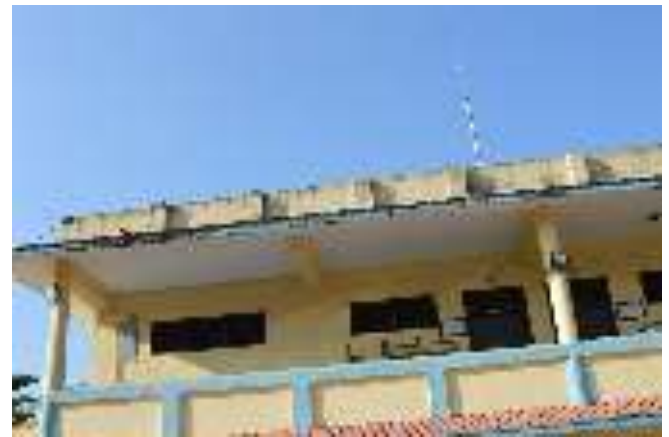
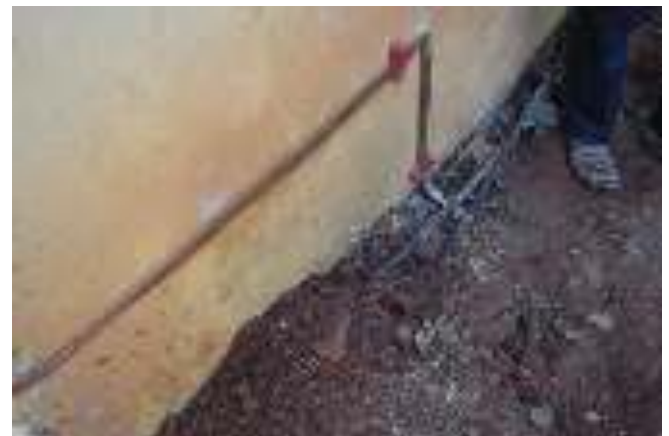
Figure 8: Photographs of (a) Conventional lightning protection system installed on a school building of Neelkantha municipality of Dhading Nepal. As is seen in the photograph the protrusions of the building have not been covered.

(b) The down conductor left bare within the reach of school children. This installation neither addresses the measures against step potential nor has taken into account of the trees surrounding the school building.

In addition to inappropriate usage of non-conventional lightning protection system, some practices on conventional system can also be seen. However, lack of knowledge on the scientific method as IEC 62305, they fail to comply with standards and often lead to increase the risk instead of mitigating. An example of such installation has been observed in some structures at Neelkantha municipality of Dhading district, Nepal. As seen in the photographs in figures

8 (a) and (b), lightning protection system installed on school building of Neelkantha, fails to protect the protrusions and the bare down conductors are seen within the easy reach of humans. One can clearly see that the installation was done without proper field assessment and fail to comply with the standards set by IEC 62305-3. A field assessment of the lightning protection system on the school building was conducted during which it was observed that the installation of down conductor system does not follow the measures set by the standards (IEC 62305) and were seen to have sharp bends as in the figure 8 (b).

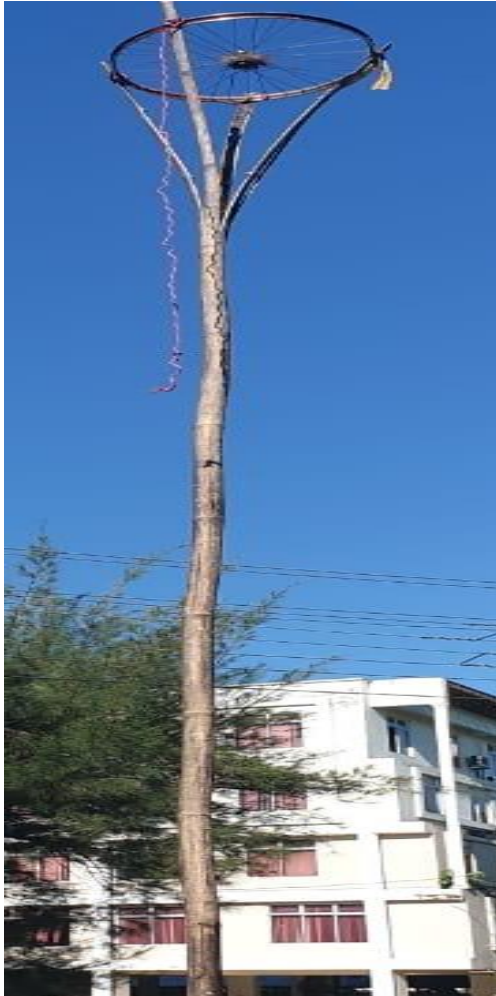
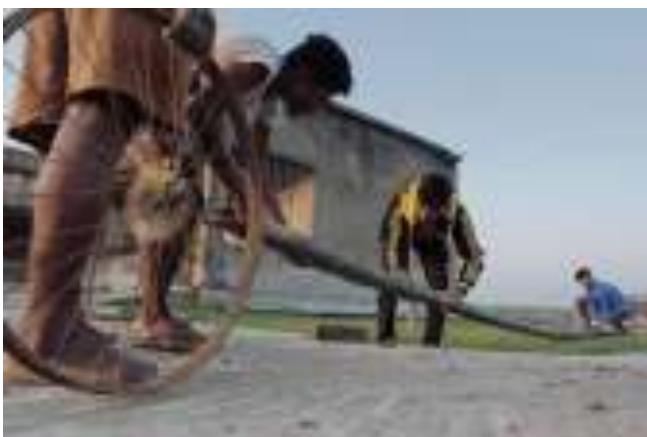
Figure 9: Photographs of (a) Bicycle wheel erected on a bamboo pole being advocated as magical lightning arrester that protects people in the area (b) Villagers preparing for the installation of bicycle rim on a bamboo post (photograph courtesy BBC news: <https://www.bbc.com/news/world-asia-india-59006609>). (Note: such practices have reportedly been awarded for the invention by one of the states in India).

In the recent past, a few people in India came up with a concept that a simple indigenous device that may give personal protection in a range that varies from a few hundred meters to a few kilometers. Such devices consist of a metal wheel (basically a bicycle rim) placed on the top of a few meters long bamboo pole as shown in figures 9 (a), & (b). Claiming the arrester to be magical, the proponent has been claiming that installing such arresters in some states has mitigated the loss of lives by about 60% compared with the previous years. It is not clear how such metal wheels provide protection scientifically. The proponents also fail to provide any evidence in which such system protecting humans while
