# Electrical Insulation for Rotating Machines

Design, Evaluation, Aging, Testing, and Repair

SECOND EDITION

Greg C. Stone, Ian Culbert,  
Edward A. Boulter, Hussein Dhirani

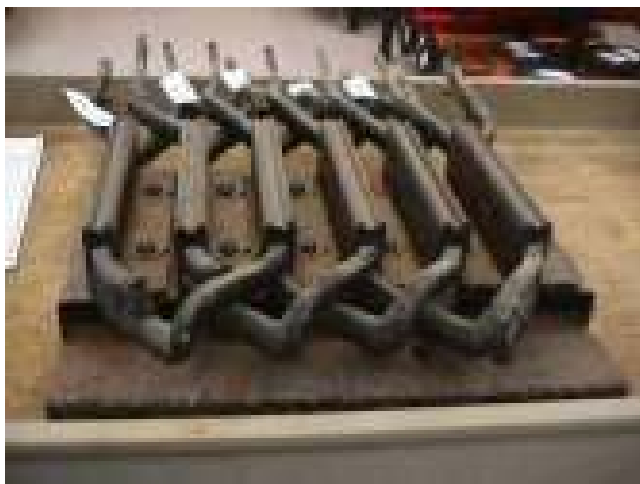
Figure 2.2 Photograph of a formette containing four multi-turn coils after a thermal endurance test (Source: Eltek Laboratories).

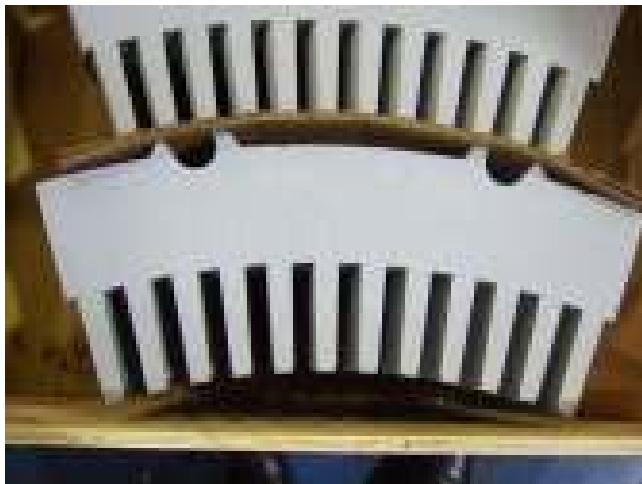
Figure 6.3 Segmented stator core laminations used in large diameter stator cores.

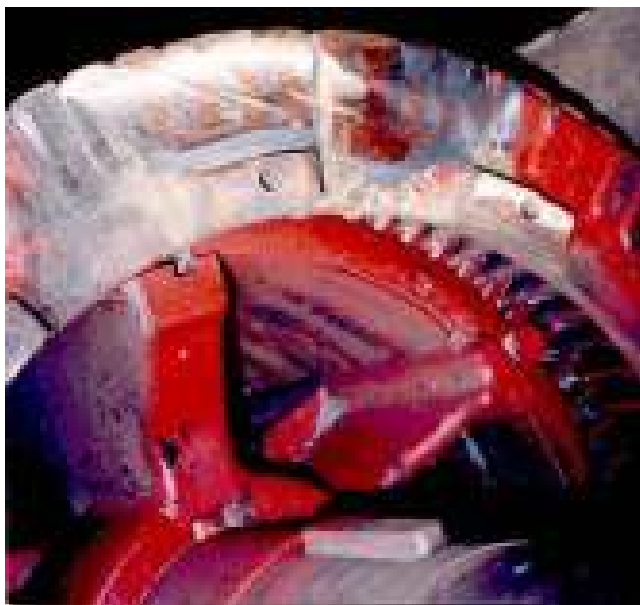
Figure 6.5 Core supported by spider arms mounted on a hub.

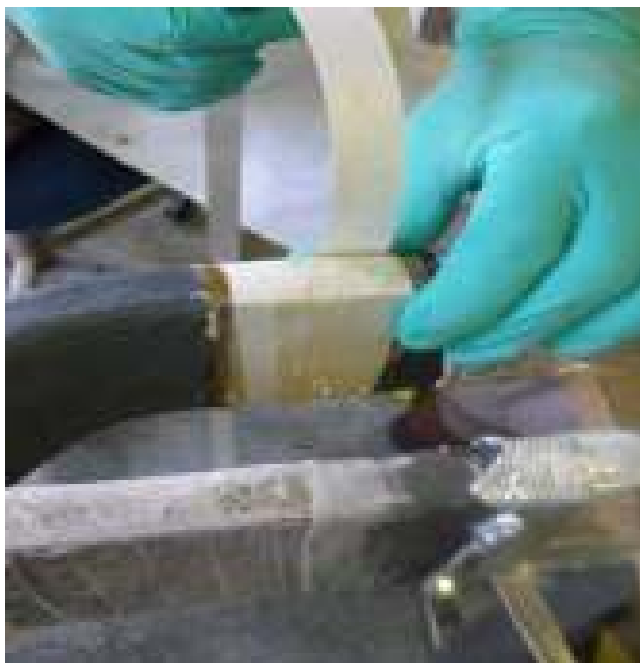
Figure 7.1 A coil that is in the process of being repaired after the coil insulation was accidentally crushed by a hammer blow just outside of the stator slot (Source: Courtesy Iris Power-Qualitrol).

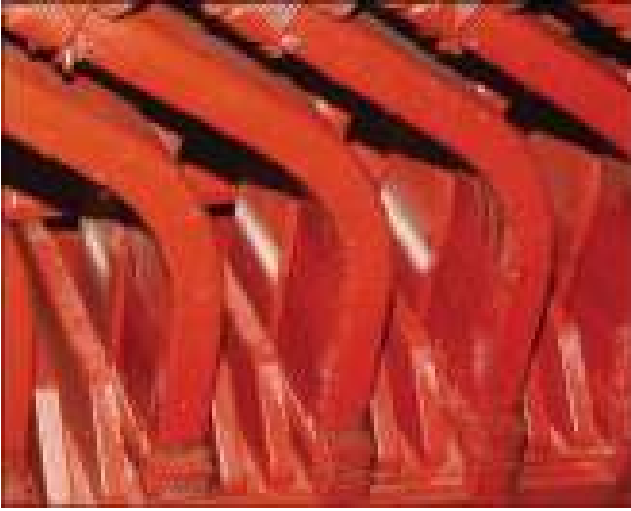
Figure 8.10 Photograph of the end winding area from a hydrogenerator. The white band around some of the coils just outside the slot indicates where the coating overlap area has degraded. Note that the entire stator has been painted with an abrasion resistant coating that makes repair of the overlap problem very difficult.

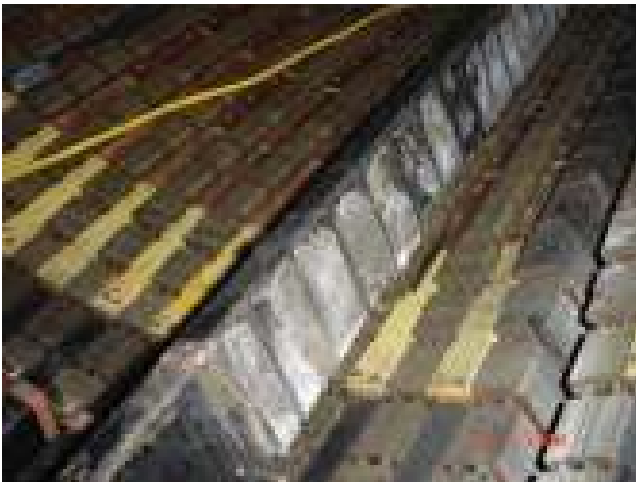
Figure 8.12 A stator bar being removed from an air-cooled turbine generator affected by VS.

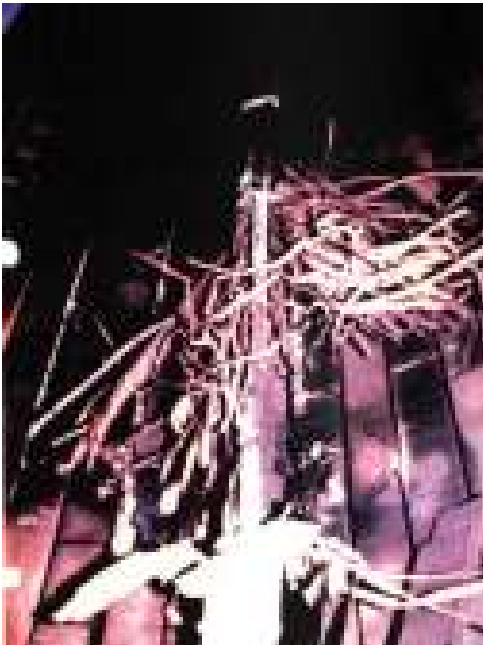
Figure 8.13 View of the stator bore (after rotor removal) of an 800 MVA turbogenerator that experienced a phase-to-phase fault in the stator slot. The white “spaghetti” are the copper conductors that came out of the stator slot under the tremendous magnetic forces that accompany a phase-to-phase fault.

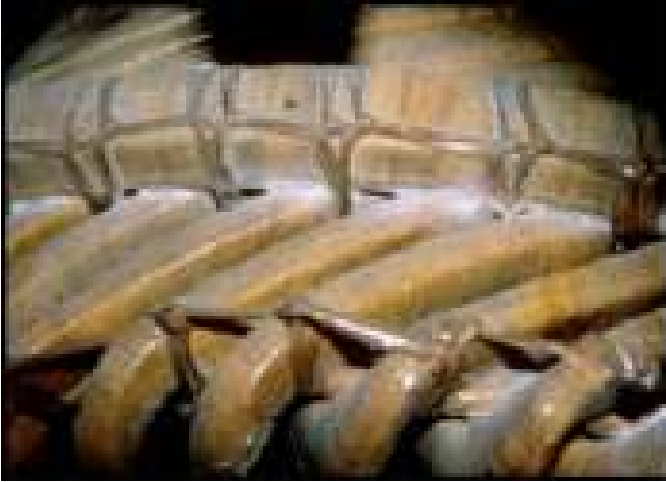
Figure 8.21 The white areas indicate fretting due to end winding vibration where the coils are lashed to a support ring in a motor stator.

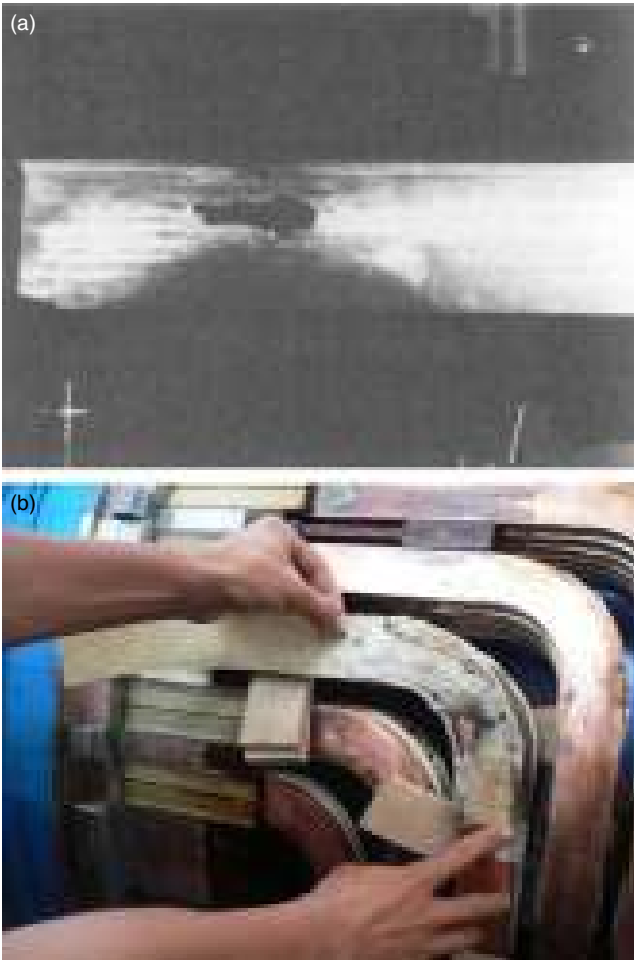
Figure 9.1 (a) Abrasion of ground insulation by conductors at the end of the slot due to thermal cycling. (b) Abrasion of the turn insulation in the end winding (Source: Photo courtesy of Guondong EPRI).

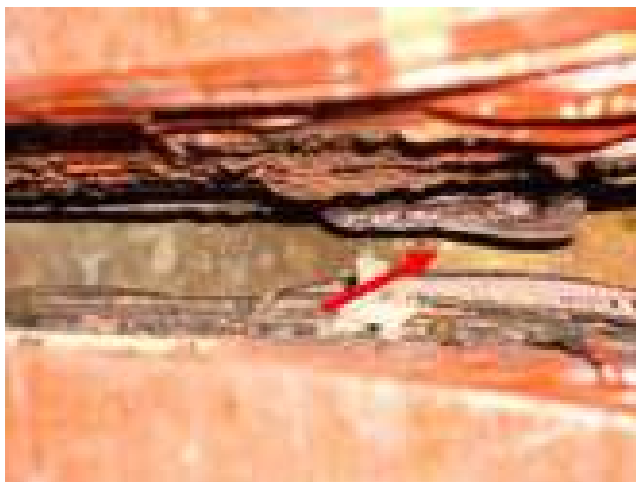
Figure 9.3 Failed pole jumper connection.

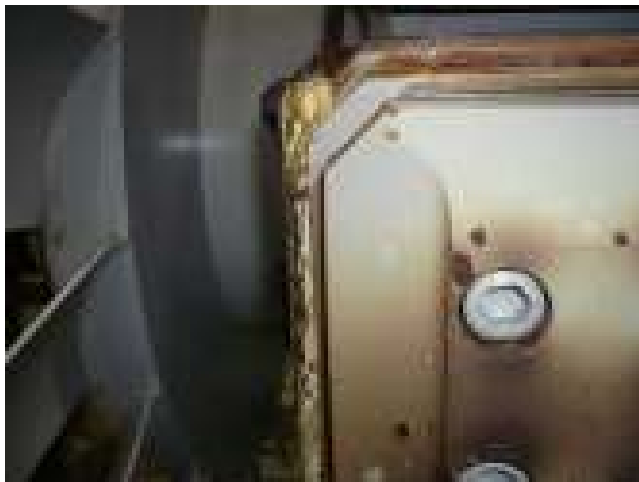
Figure 10.1 Strip-on-edge winding turn insulation migration from thermal aging of the bonding resin.

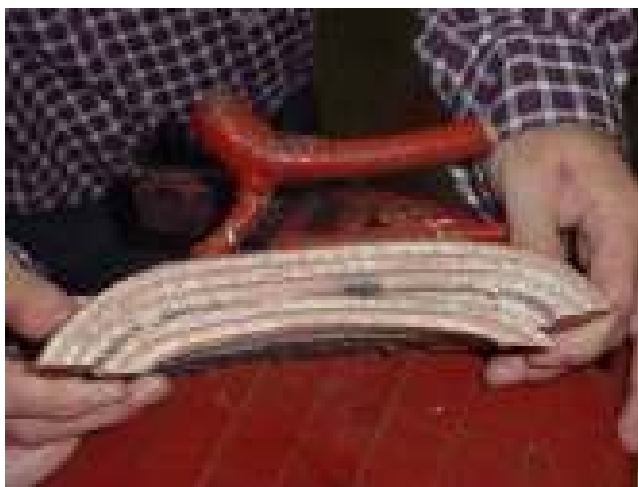
Figure 10.2 Turn insulation in wire wound coil resulting from cracking of the bonding resin as a consequence of thermal cycling.

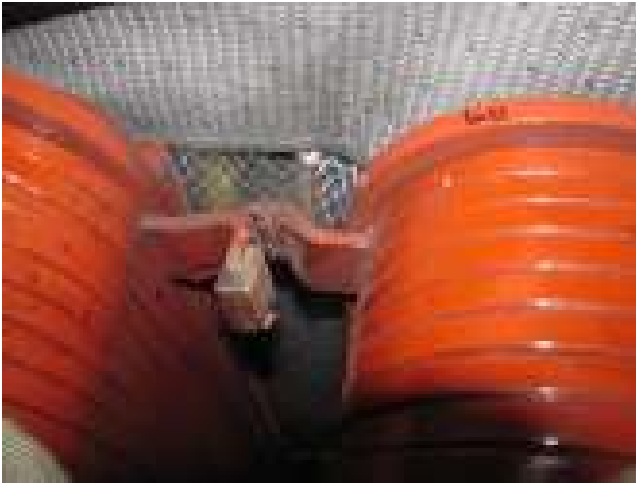
Figure 10.3 Failure of inter-pole connection from thermal cycling.

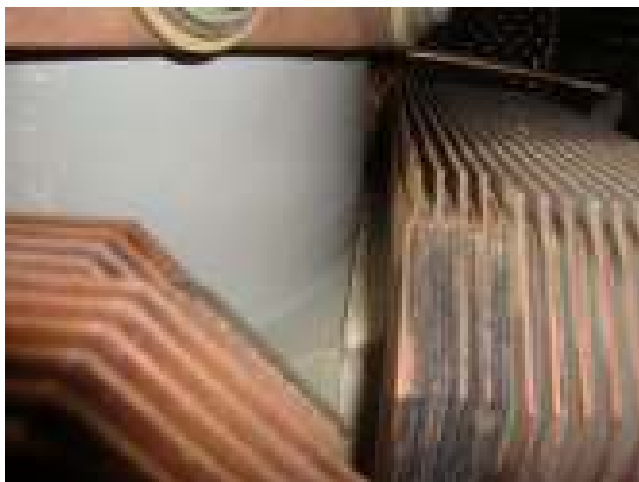
Figure 10.4 Contamination of a strip-on-edge field winding pole.

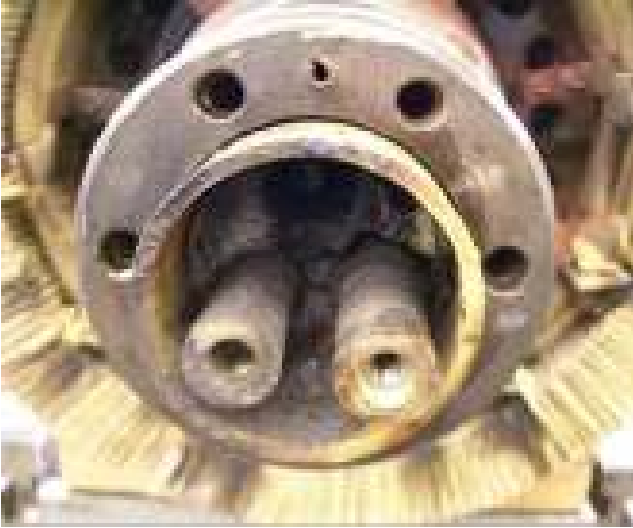
Figure 11.2 Rotor winding lead insulation failure from interphasal partial discharges.

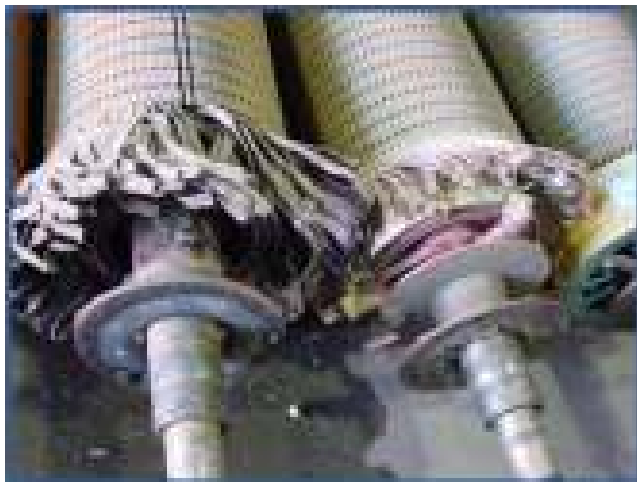
Figure 11.3 Two wound rotors in which the end winding banding has failed.

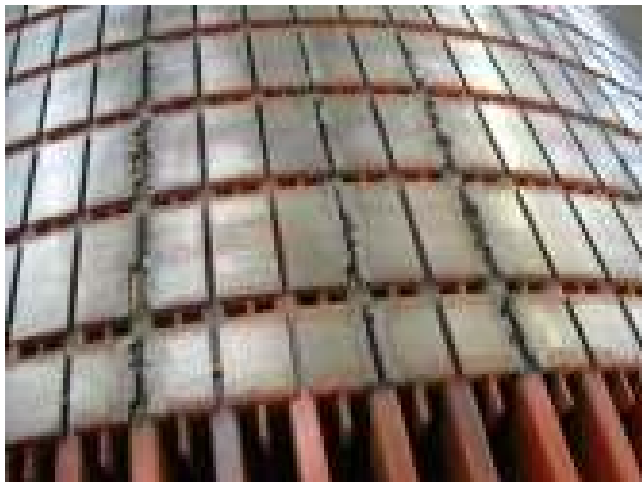
Figure 12.8 Core bridge burning due to loose bars in slots (Source: Courtesy of EASA).

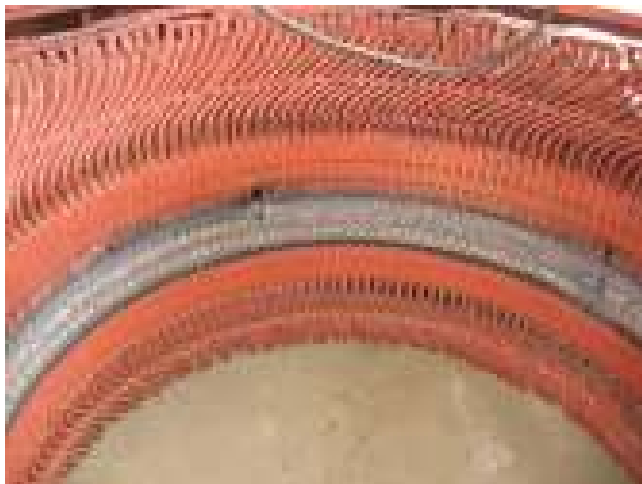
Figure 13.6 Large slow speed motor stator rub from rotor pull over the rub is in the middle of the stator core, at the lighter colored area.

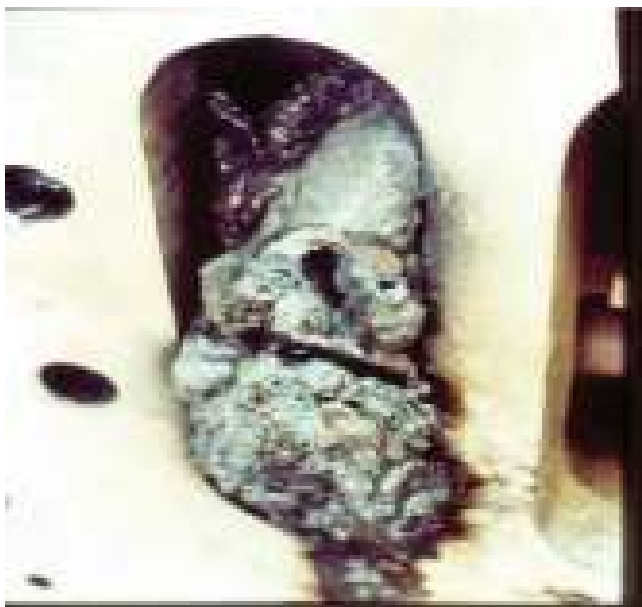
Figure 13.8 Massive core melting with molten steel coming out of the axial vent ducts in a large turbo generator.

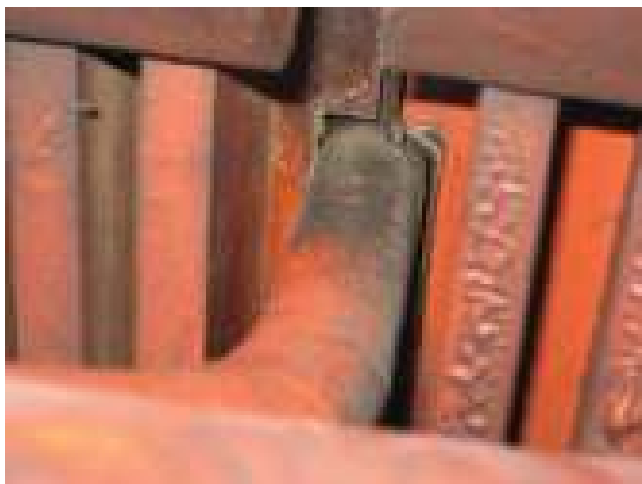
Figure 13.9 Split core packing movement.

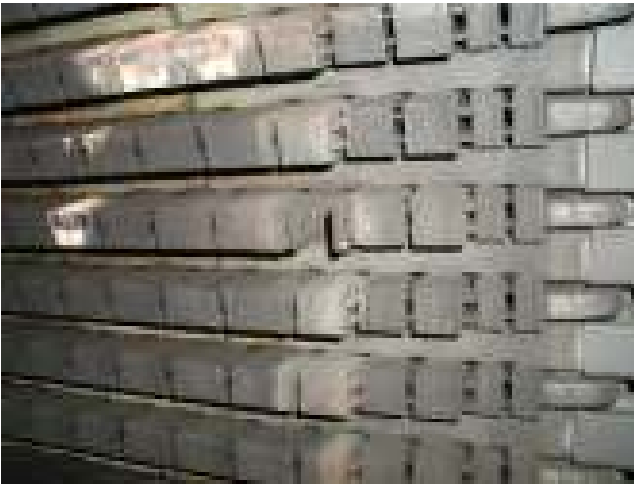
Figure 13.11 Core damage from a loose bolt.

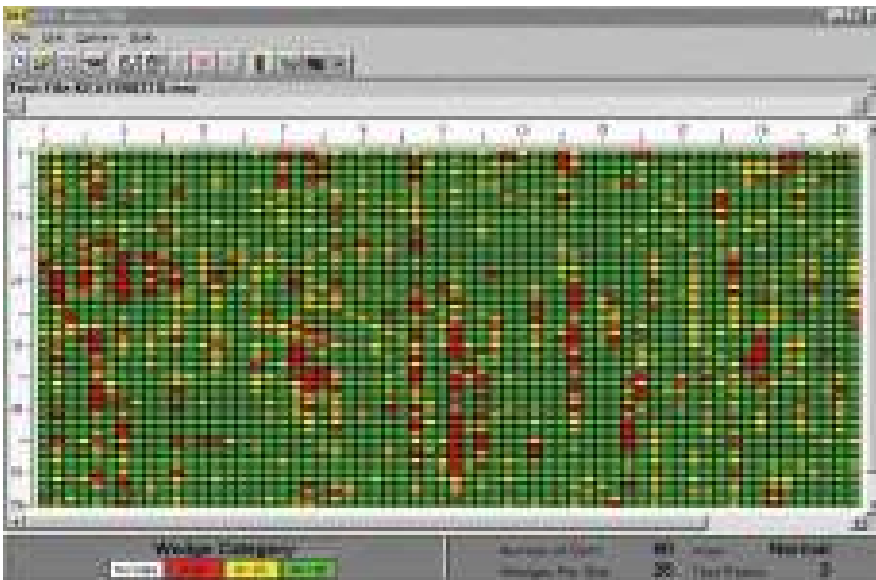
Figure 15.9 Map of wedge tightness versus slot number (vertical scale) and axial wedge number (horizontal scale). Green is tight, red is loose, and yellow is indeterminate. (Source: Iris Power-Qualitrol). See color plate section.

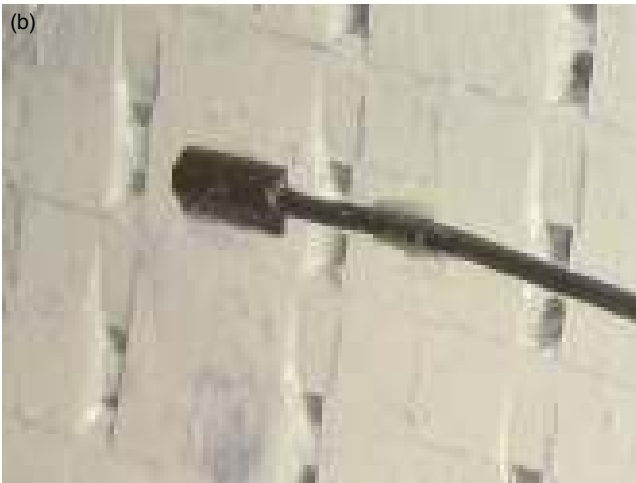
Figure 16.13 (a) A photo of a conventional wedge-mounted foldable flux probe that projects into the air gap. (b) A photo of an installed flat flux probe glued to a stator tooth. (Source: Iris Power-Qualitrol.)

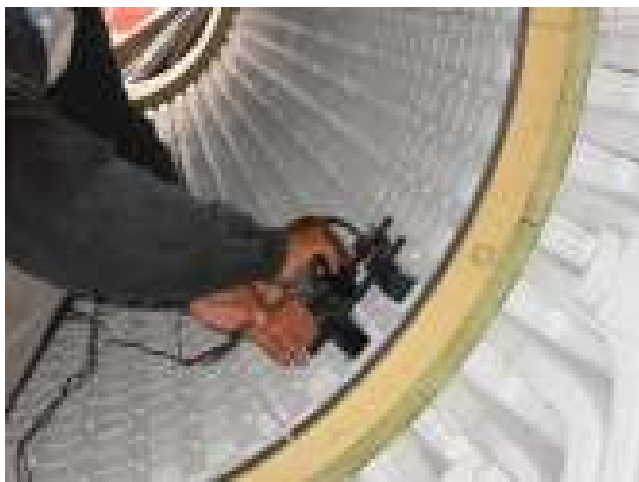
Figure 17.15 EI-CID trolley with Chattock coil mounted.

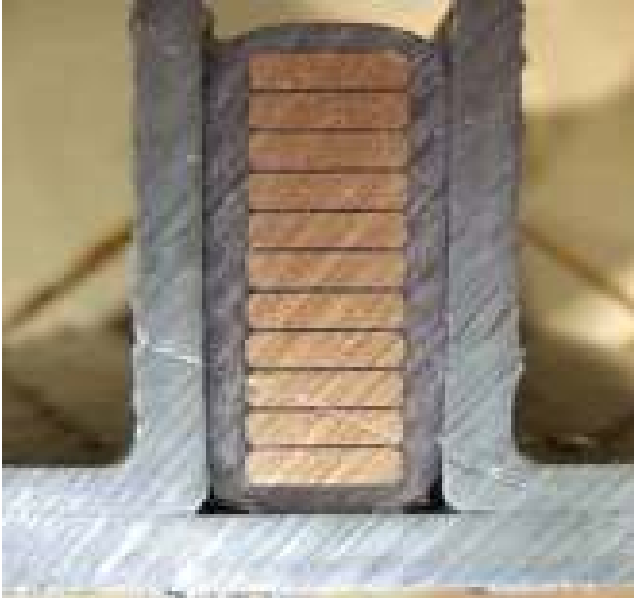
Figure 18.5 Section of sample global VPI'd coil in simulated slot.

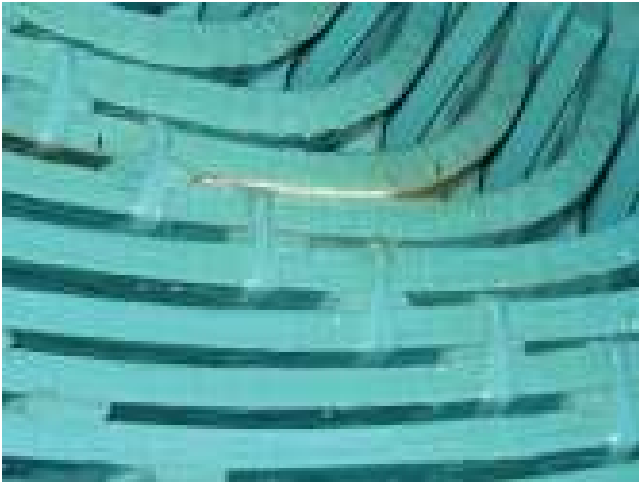
Figure 8.20 PD between adjacent coils in different phases results in white powder on the stator bar surfaces.

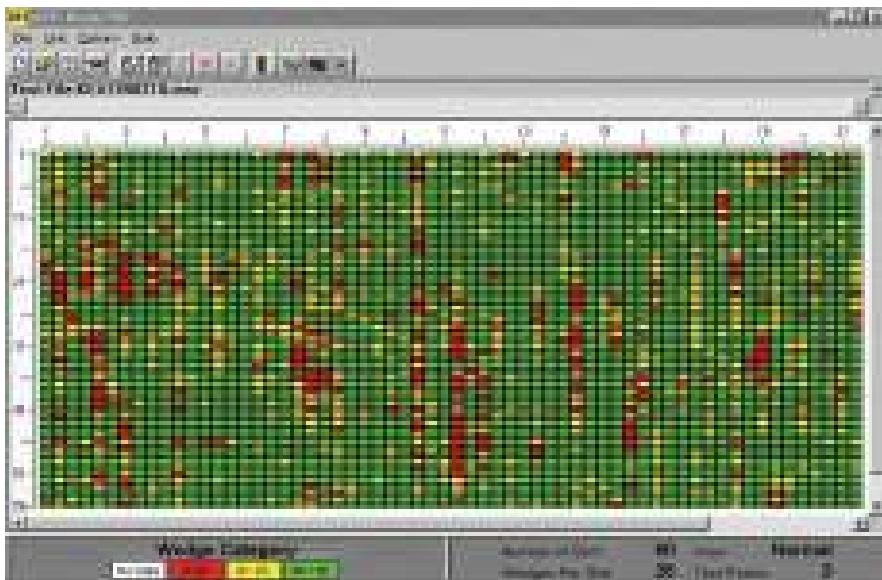
Figure 15.9 Map of wedge tightness versus slot number (vertical scale) and axial wedge number (horizontal scale). Green is tight, red is loose, and yellow is indeterminate. (Source: Iris Power-Qualitrol).
